**DISASTER RISK MANAGEMENT FOR RESILIENT PUBLIC  
SCHOOL BUILDING IN SAMAR**

A Dissertation  
Presented to  
The Faculty of the Graduate Studies  
**SAMAR STATE UNIVERSITY**  
Catbalogan City

In Partial Fulfilment  
of the Requirements for the Degree  
**DOCTOR OF PHILOSOPHY**  
**Technology Management**

March 2018

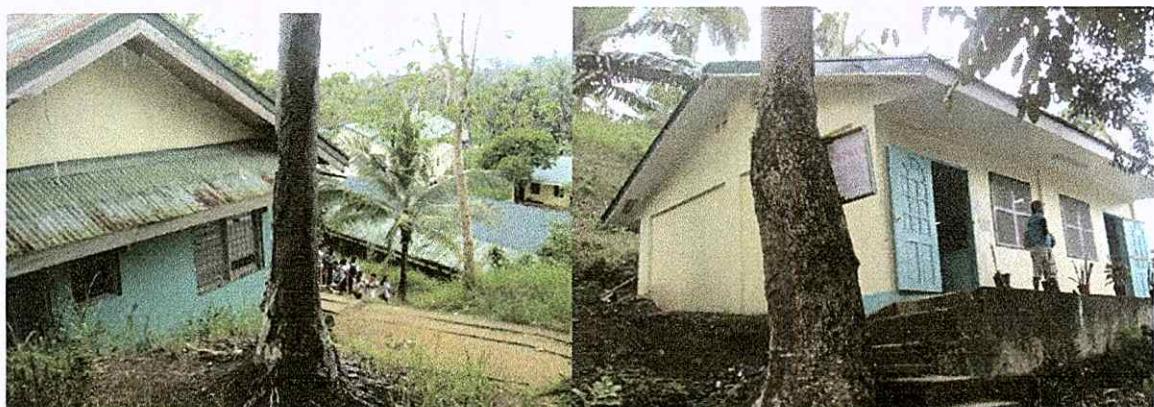
Figure 29. School buildings along slopes (L) School building along slopes in Sta. Rita National High School (Low susceptibility to rain-induced landslide); (R) Sua National High School (High susceptibility to rain-induced landslide).

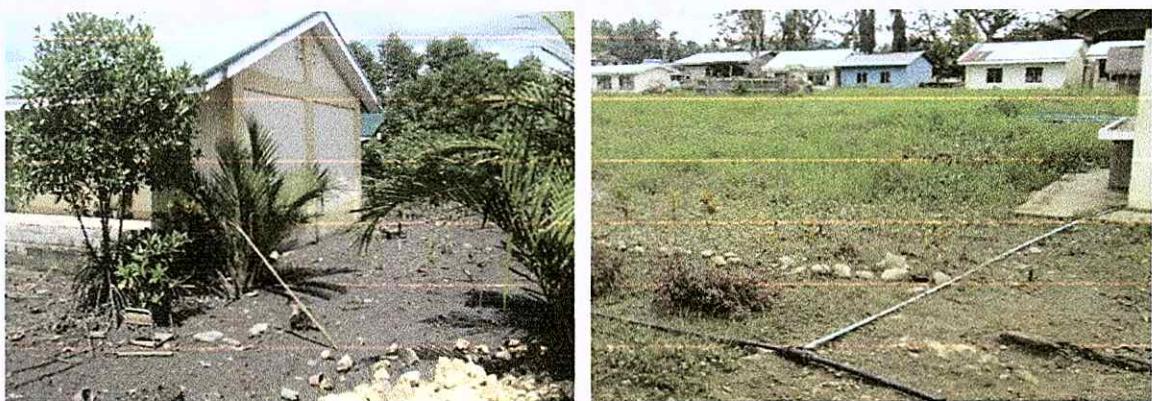
Figure 36. Low lying campus of San Sebastian NHS (L) and Anibongan Integrated School (R).

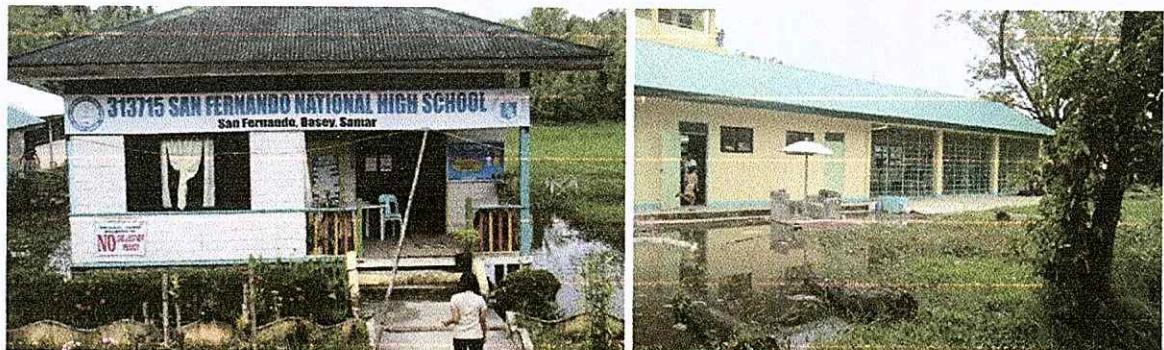
Figure 37. Flooded campus of San Fernando NHS (L) and Guinsorongan NHS (R)

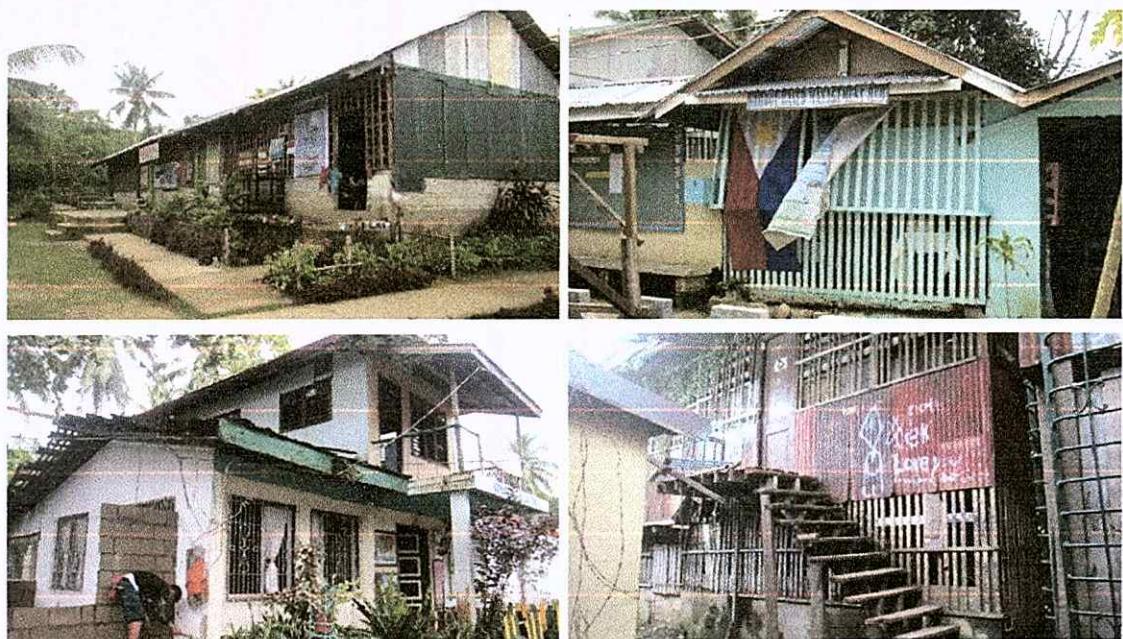
Figure 39: Fire risky makeshift Structures. Top Left: Bagacay NHS; Top Right: Calapi NHS; Bottom Left: Motiong NHS; Bottom Right: Samar National School

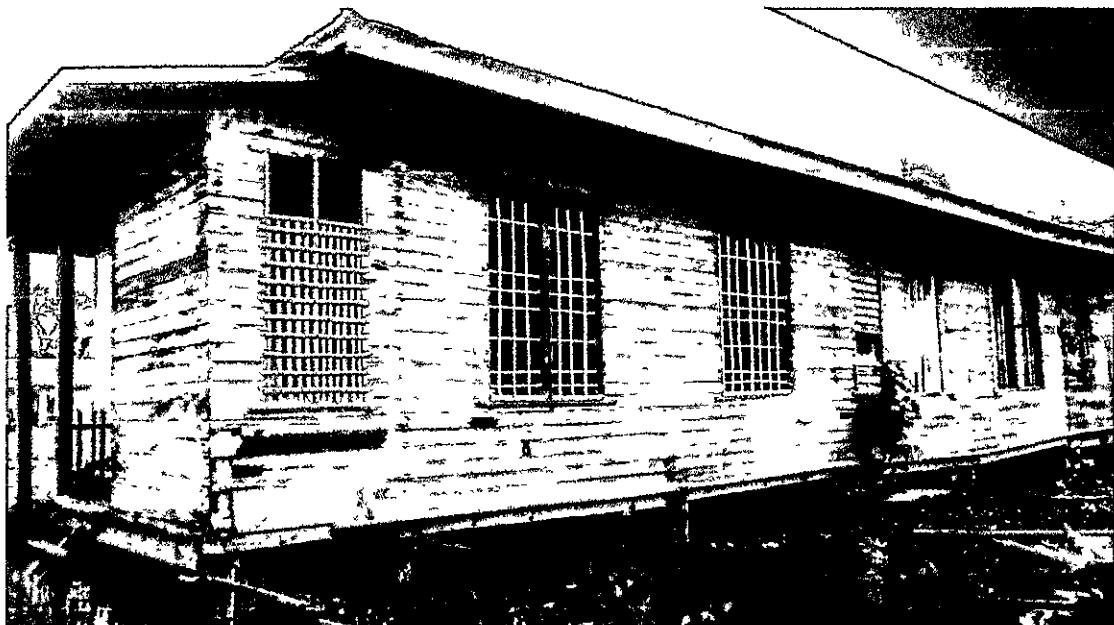
Figure 40: Typical fire risky wooden structures (San Fernando NHS Administration Building).

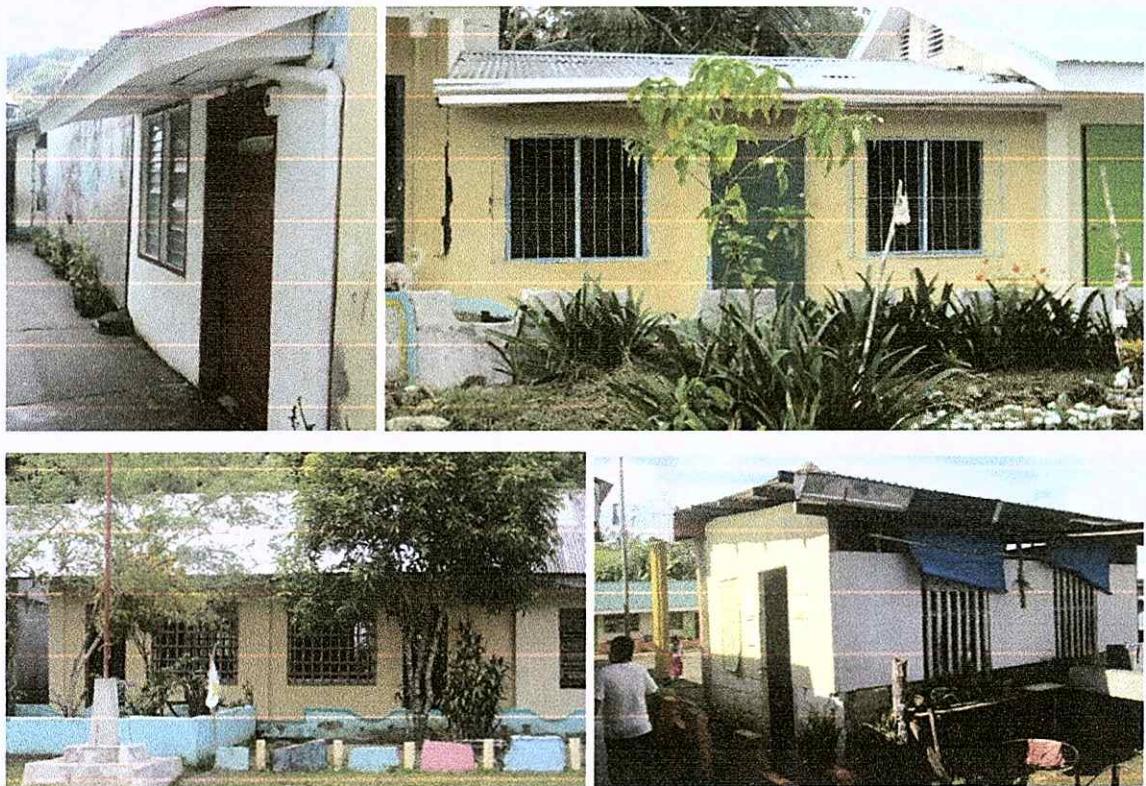
Figure 41. New but substandard structures: Top Left: Catbalogan III Office Room (2017); Top Right: Calapi NHS Classroom (2016); Bottom Left: Baclayan NHS Office (2016); Bottom Right: Parasanon NHS Reading Center (2015)

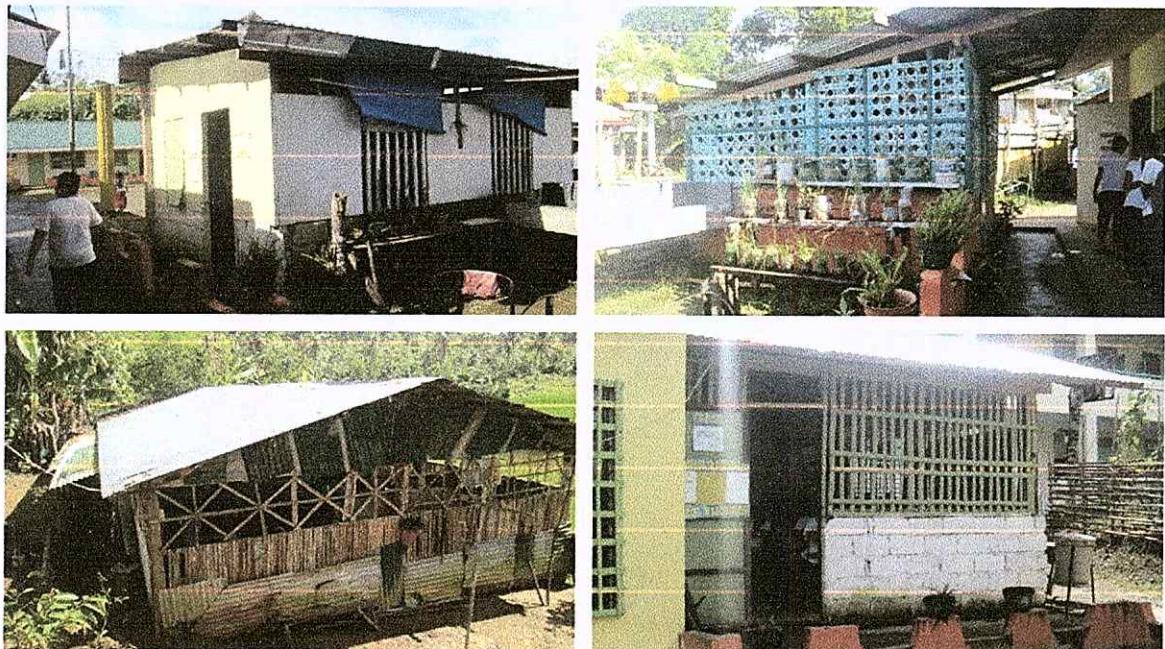
Figure 43. Makeshift rooms/structures of Parasanon NHS (Top Left: Reading Center; Top-Right: Washing Room; Bottom Pictures: Classrooms).

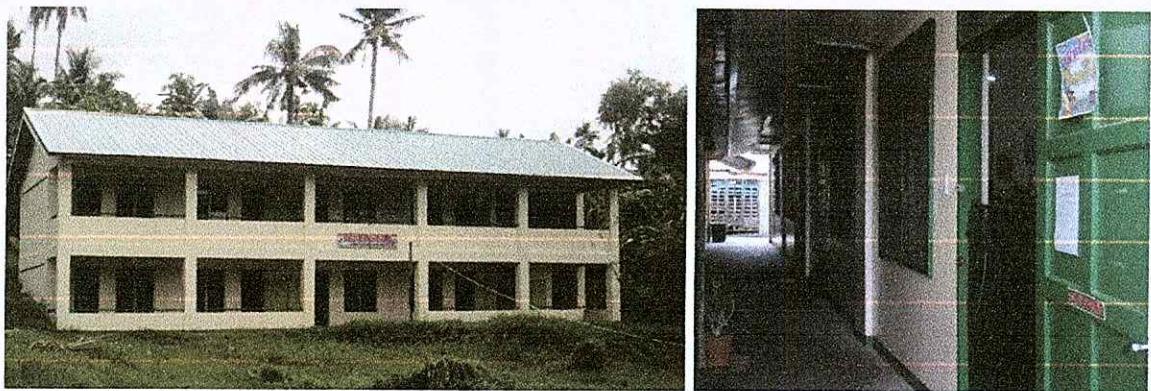
Figure 46: Design and placement deficiency. Left: Front ground absent in a Bagacay NHS building main entrance building, Right: Standard building of Catbalogan III ES but aesthetically sub-standard.

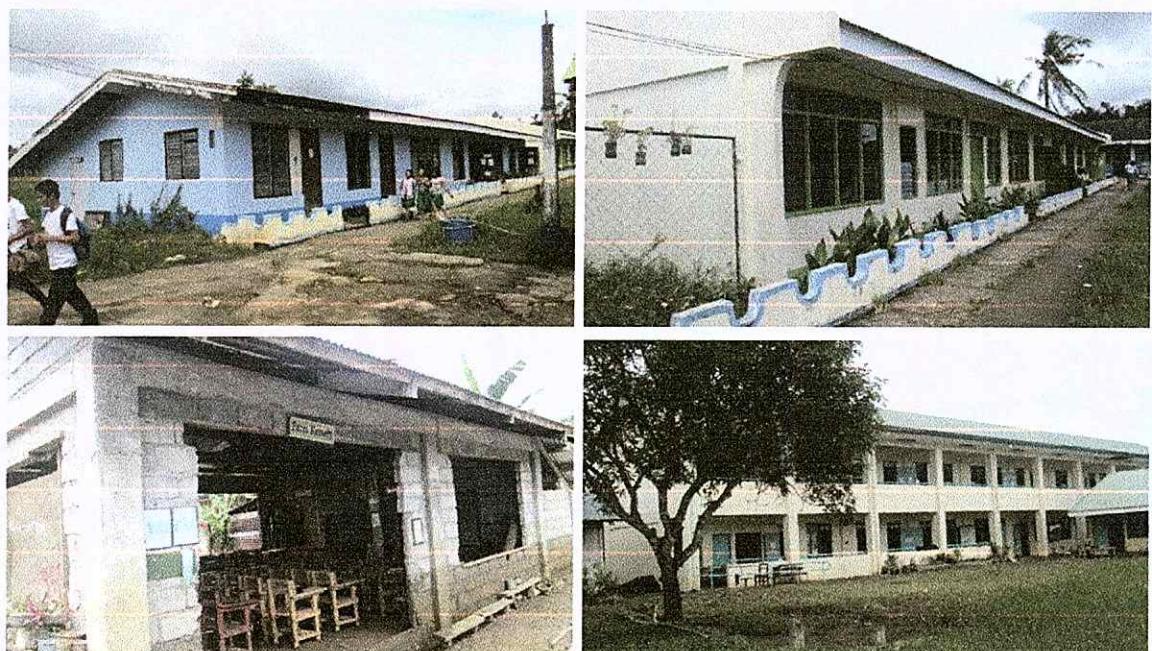
Figure 47. Example of compliant and non-compliant structures. Top pictures are VCYMAS buildings (Left: not compliant, Right: compliant). Bottom pictures are Quintin Quijano Sr. Agricultural School Buildings (Left: not compliant, Right: compliant)

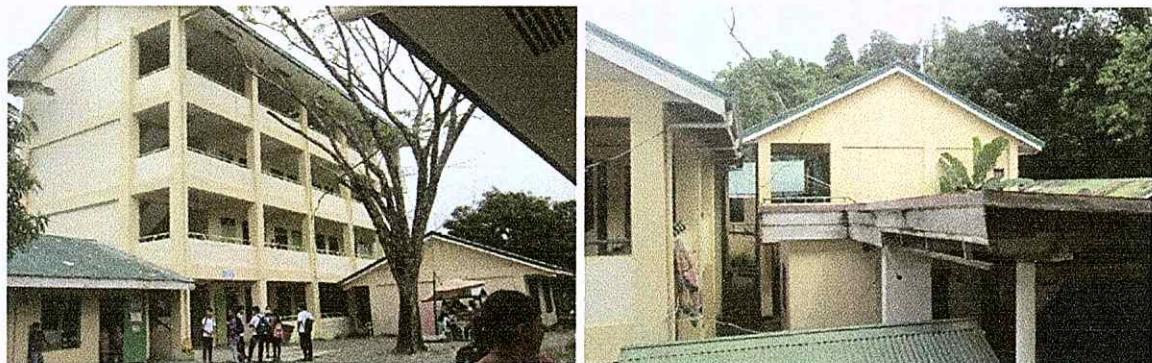
Figure 49. School buildings constructed near another building. Left: Guinsorongan NHS. Right: Catbalogan NCHS.

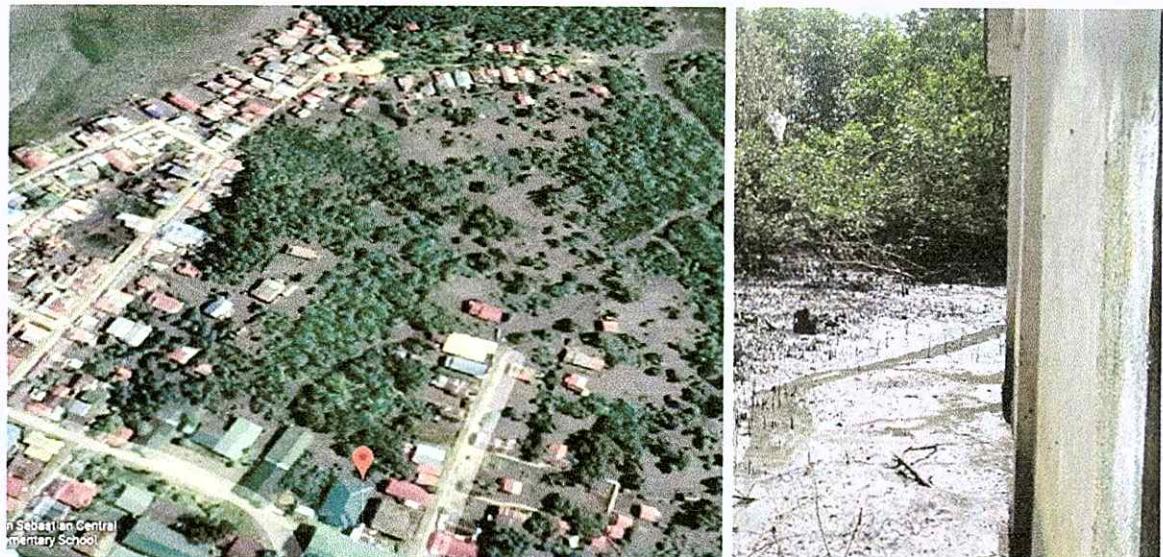
Figure 51. School buildings in hazardous areas. Left: Areal shot of San Sebastian NHS found in a marshland (Google Maps). Right: Mangroves/marsh land behind one of the classrooms in San Sebastian NHS

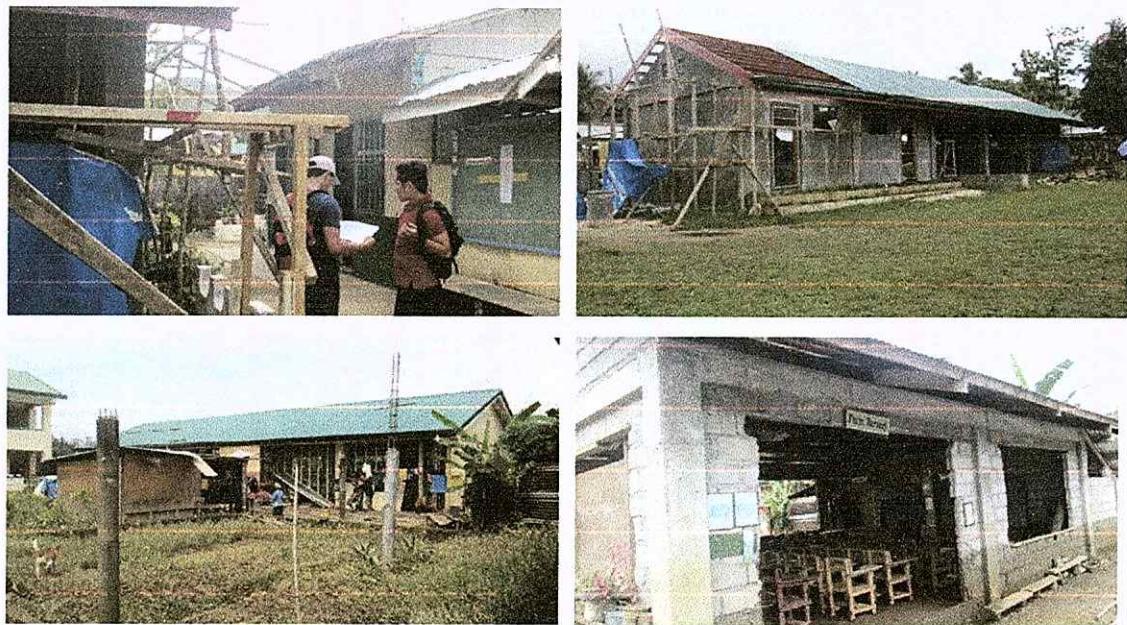
Figure 52. Buildings without construction safety measures. Top Pictures: Under construction buildings of Calapi NHS with no construction safety measures. Bottom Left: On-going construction at QQSAS NHS without construction safety measure. Bottom Right: Utilized unfinished building of QQSAS NHS.

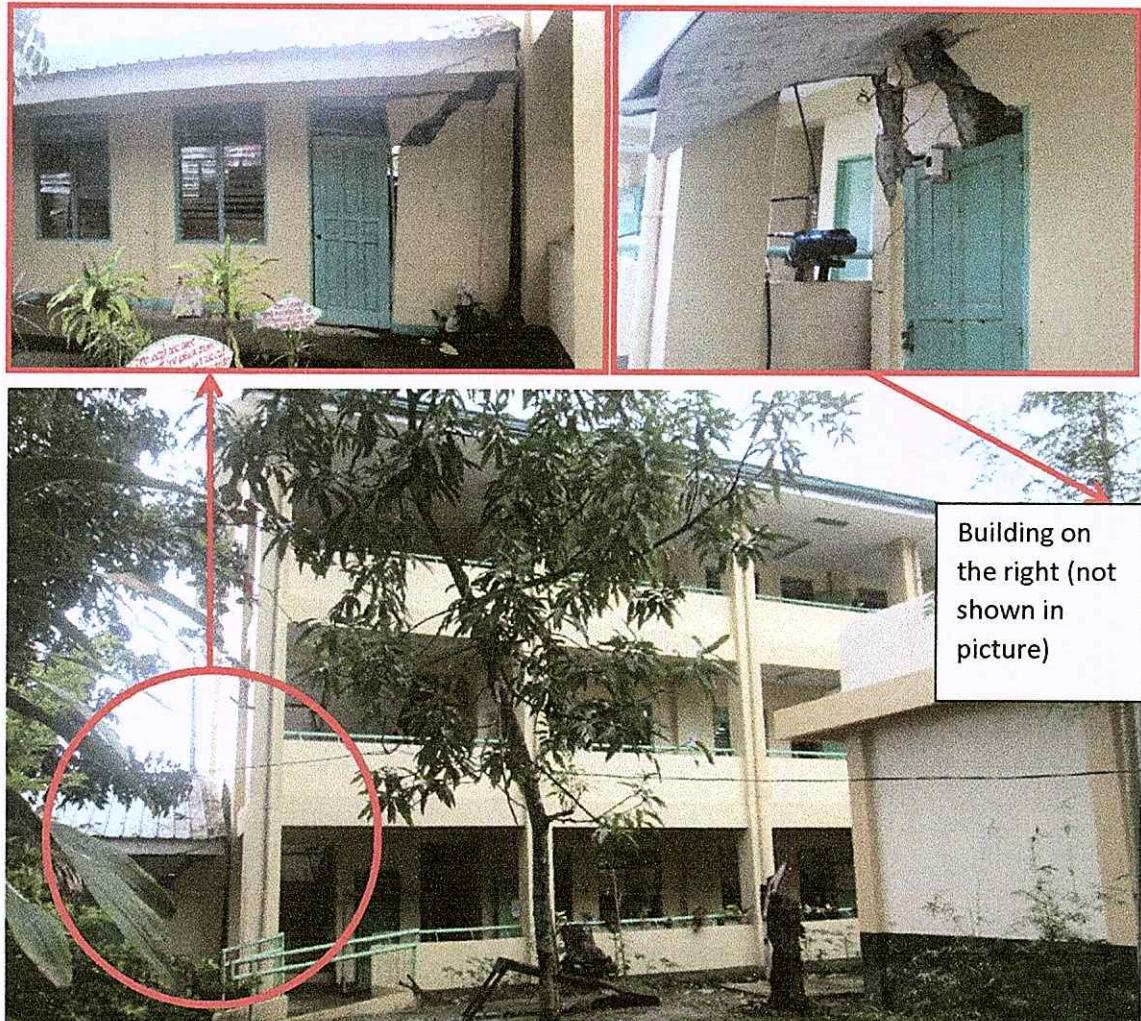
Figure 53. Damaged classrooms of Motiong NHS (top pictures)

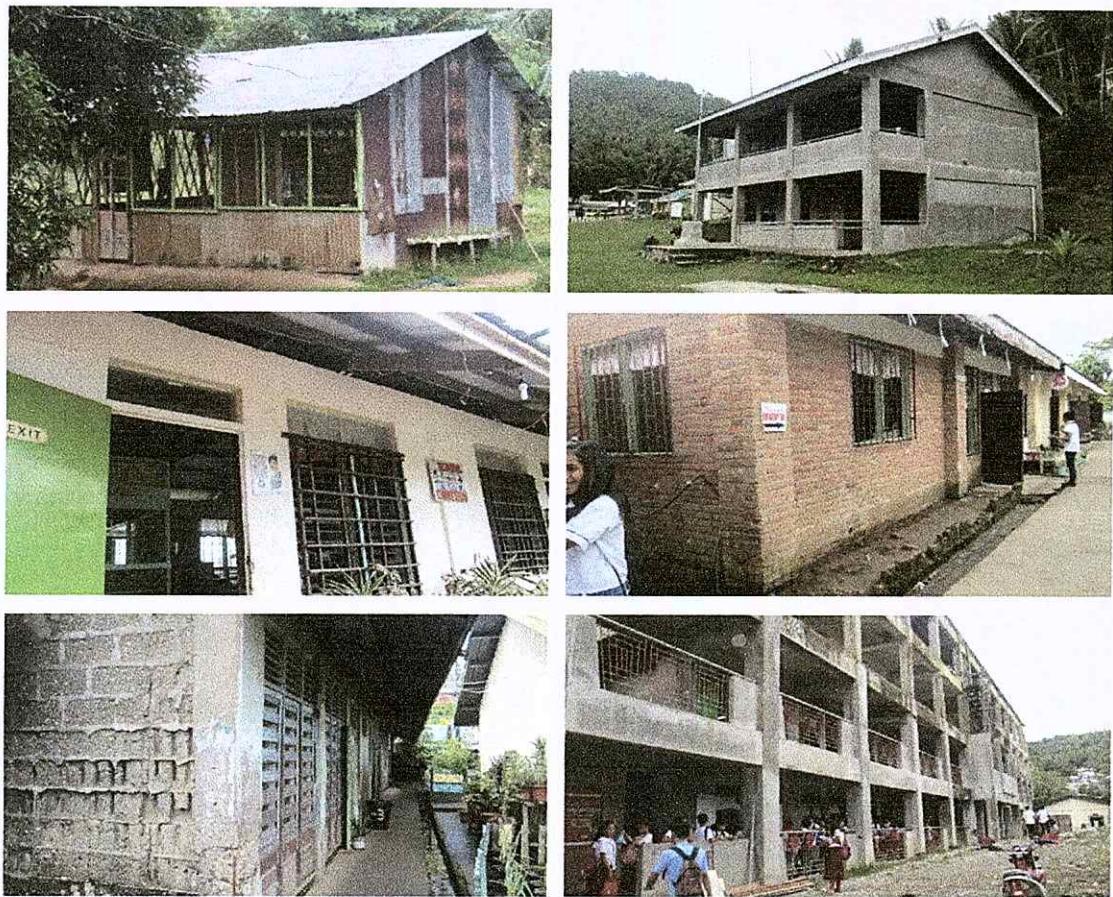
Figure 55. Highly critical to failure buildings (Top-Left) Makeshift classroom of Anibongan NHS; (Top Right) Unfinished school building of Bakhaw NHS; (Middle Left) No ceiling classroom of Calbiga NHS; (Middle Right) Bricked wall of Calbiga NHS; (Lower Left) Deteriorating CHB Wall of Catbalogan III; (Lower Right) Unfinished school building of Samar NS.

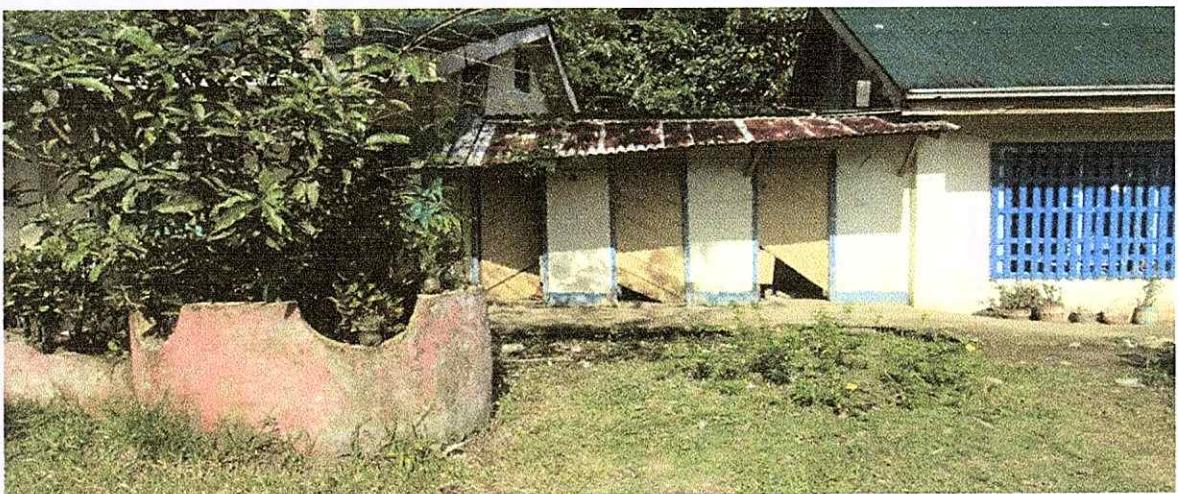
Building 6. A damage CR.

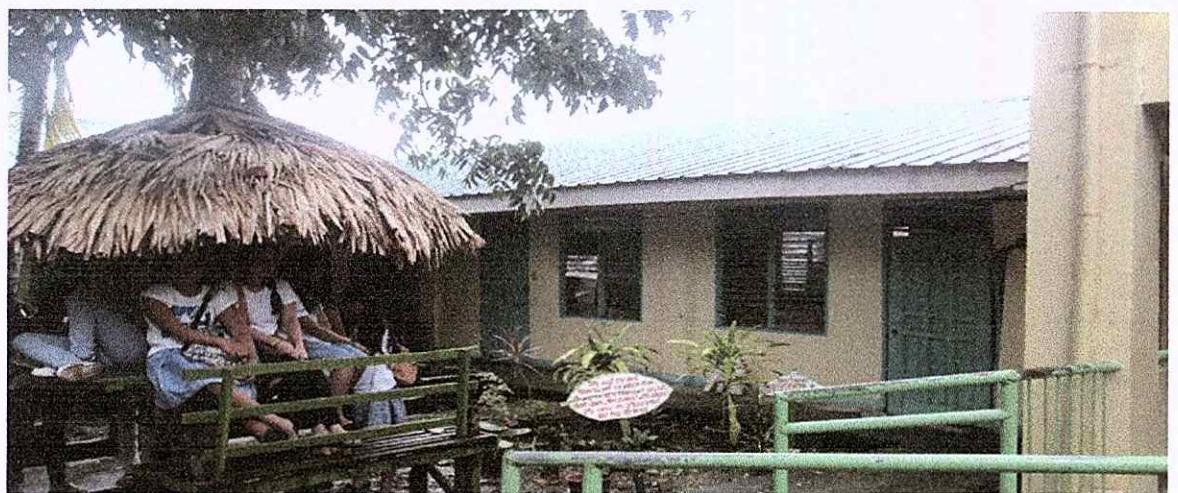
Building 6 showing one room damage due to the construction of the adjacent building (Building No. 7)

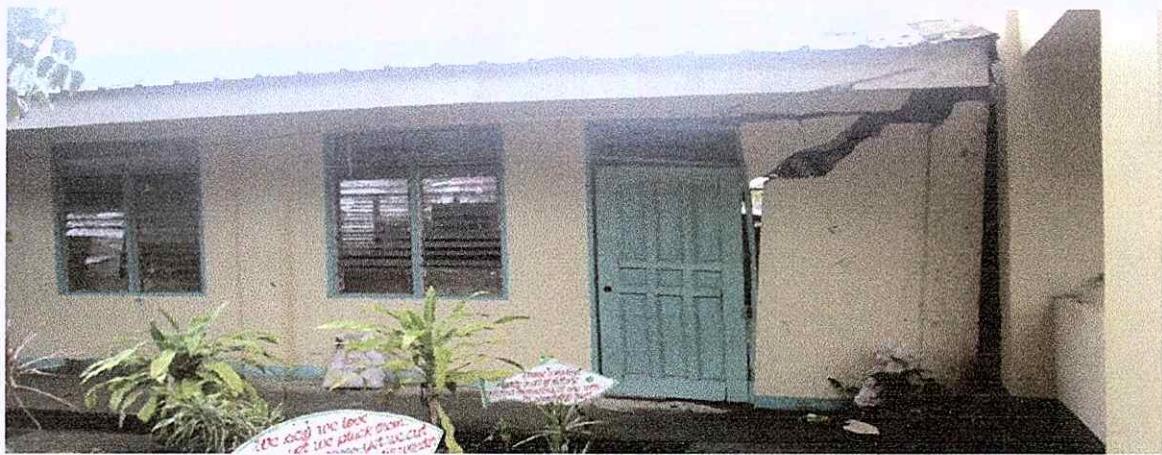
A two-room Building No. 6. A clear view of the damage room adjacent to the three-storey building

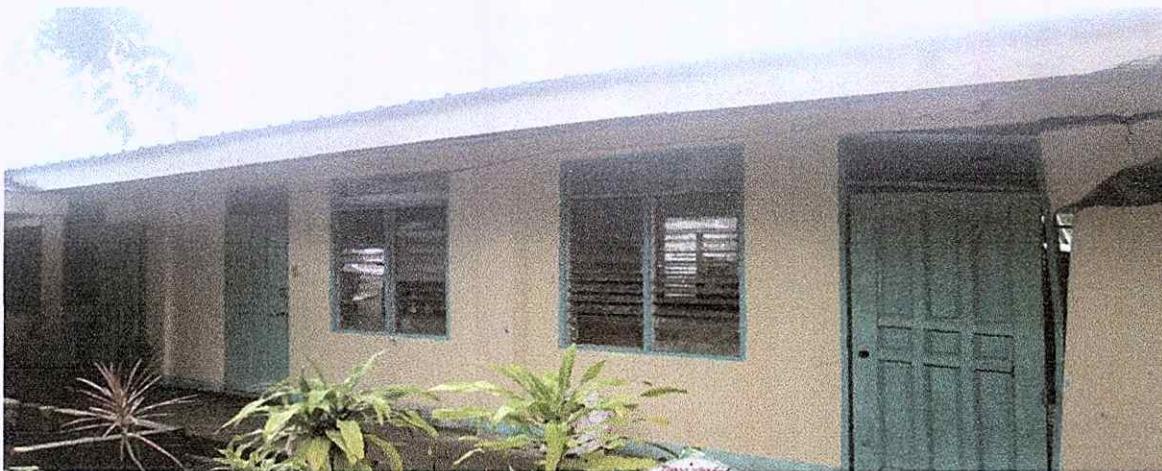
Another clear view of the damage room showing the damage portion.

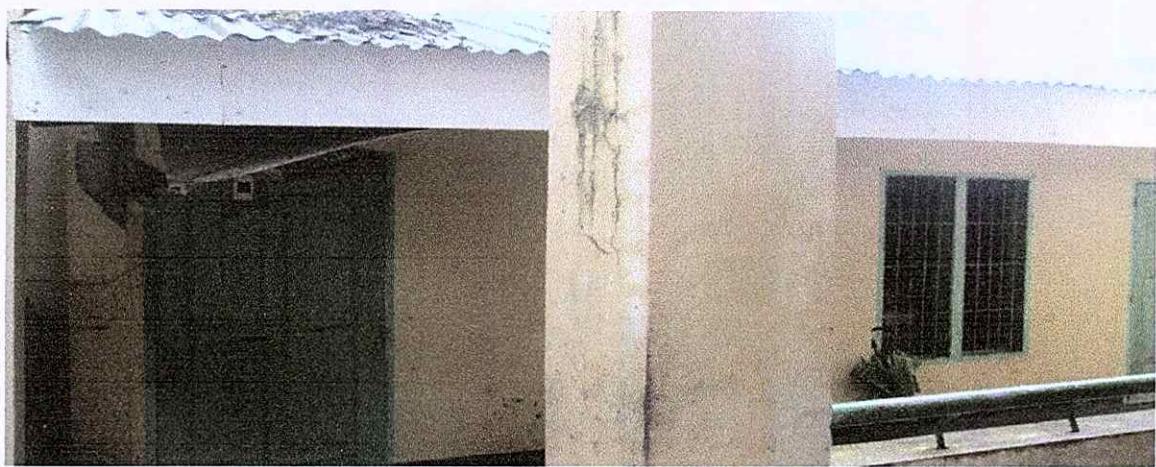
Building 8. Showing the damage portion due to the construction of the adjacent building.(Building No.

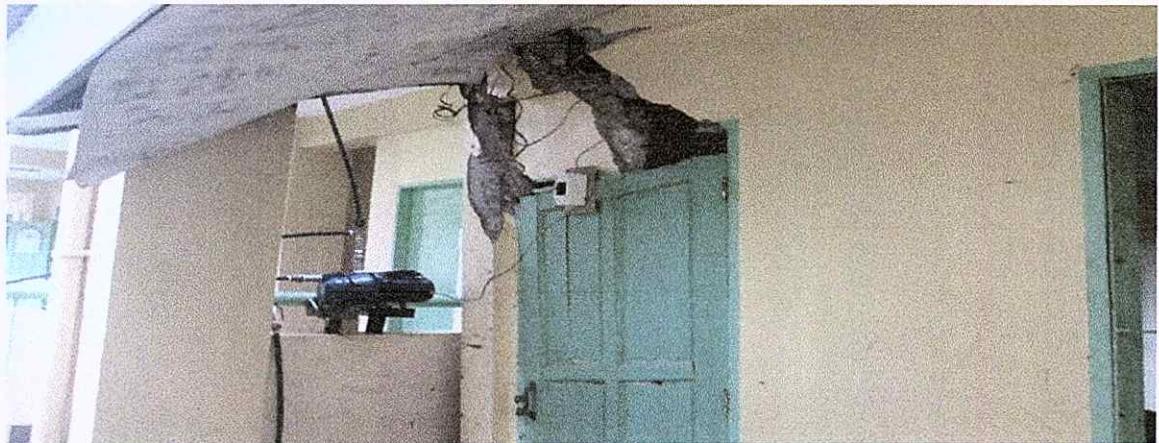
A clear view of the damage portion of Building No. 8

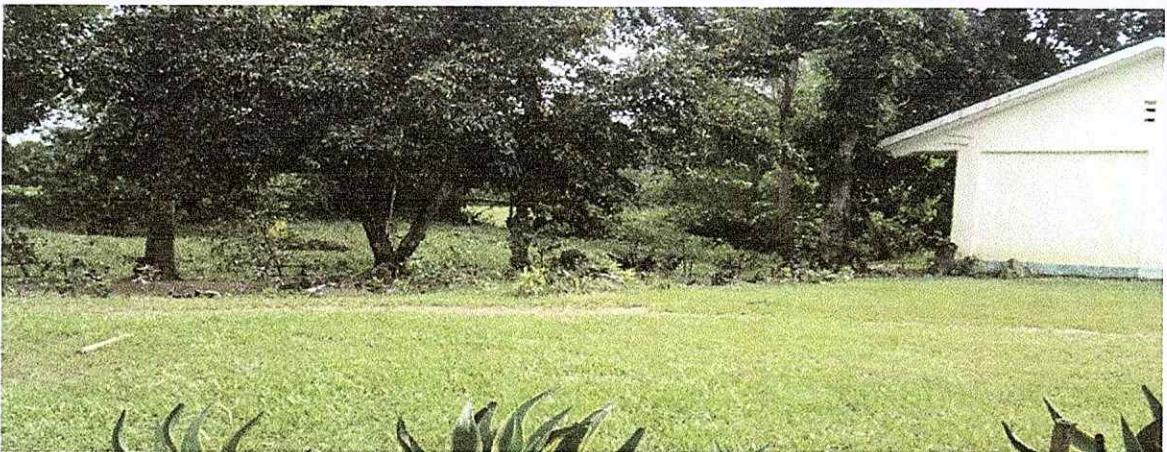
The adjacent river which causes flood to QQSAS

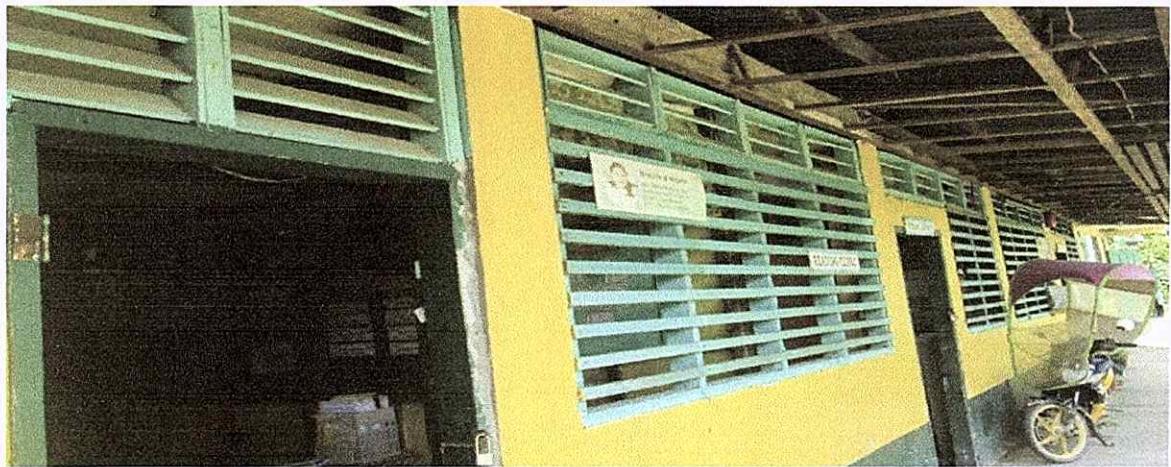
Building 11. Shown in the picture is the wooden grills on windows and the deteriorating condition of the ceiling.

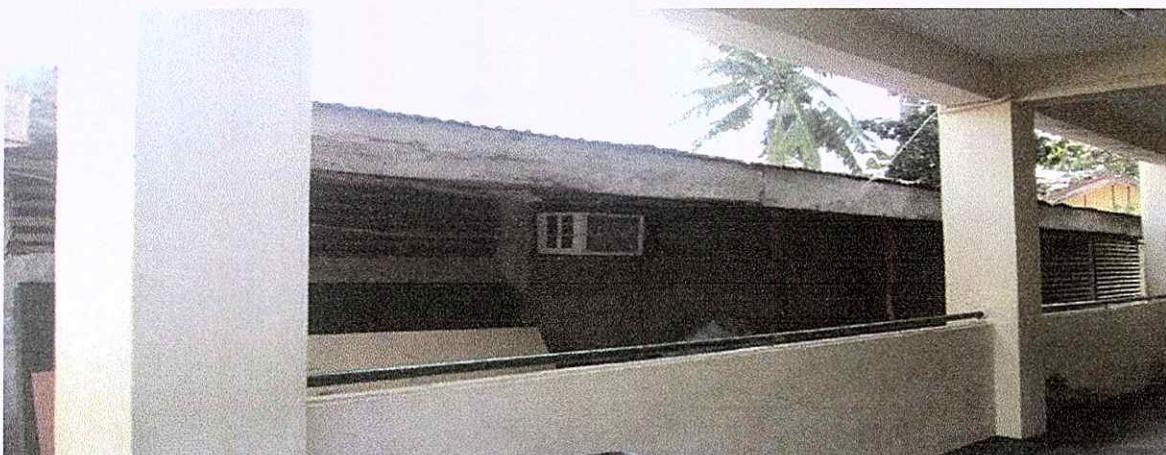
Behind Building 11 is shown the damage windows and wall.

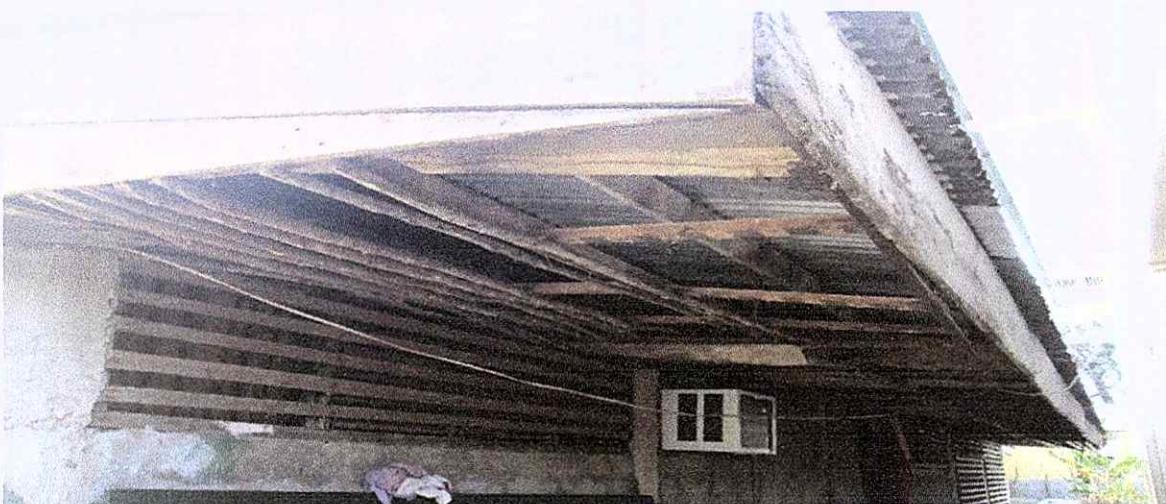
Picture shows the damage ceiling of Building 10.
