**DISASTER RISK MANAGEMENT FOR RESILIENT PUBLIC  
SCHOOL BUILDING IN SAMAR**

A Dissertation  
Presented to  
The Faculty of the Graduate Studies  
**SAMAR STATE UNIVERSITY**  
Catbalogan City

In Partial Fulfilment  
of the Requirements for the Degree  
**DOCTOR OF PHILOSOPHY**  
**Technology Management**

March 2018

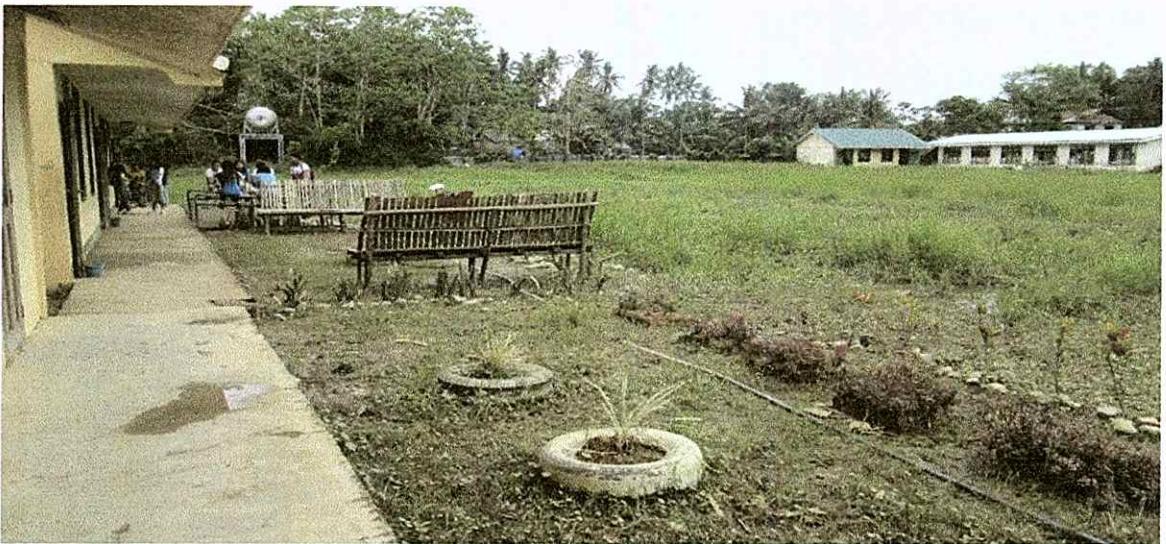
Anibongon Integrated School (AIS) campus is prone to flood

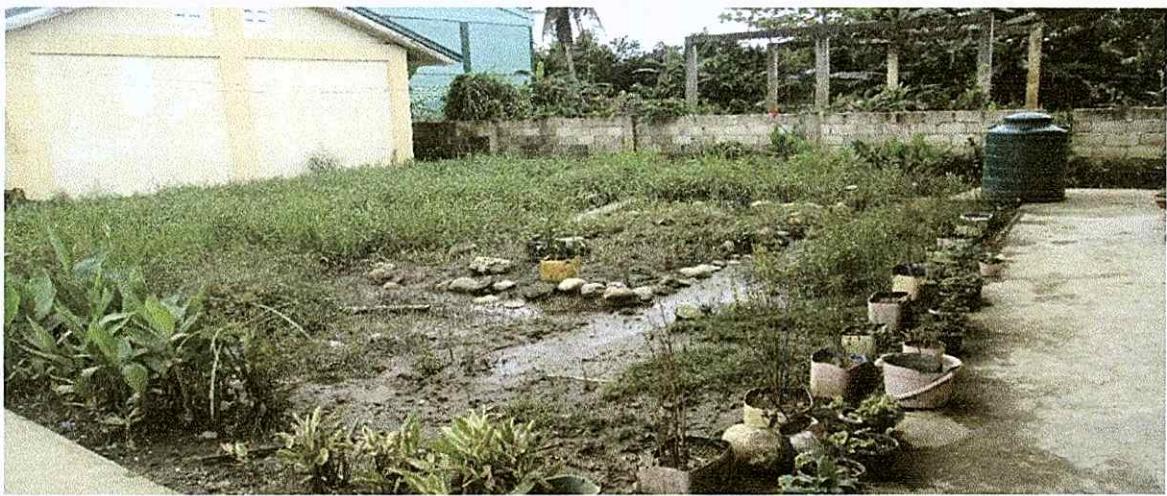
AIS campus is prone to flood

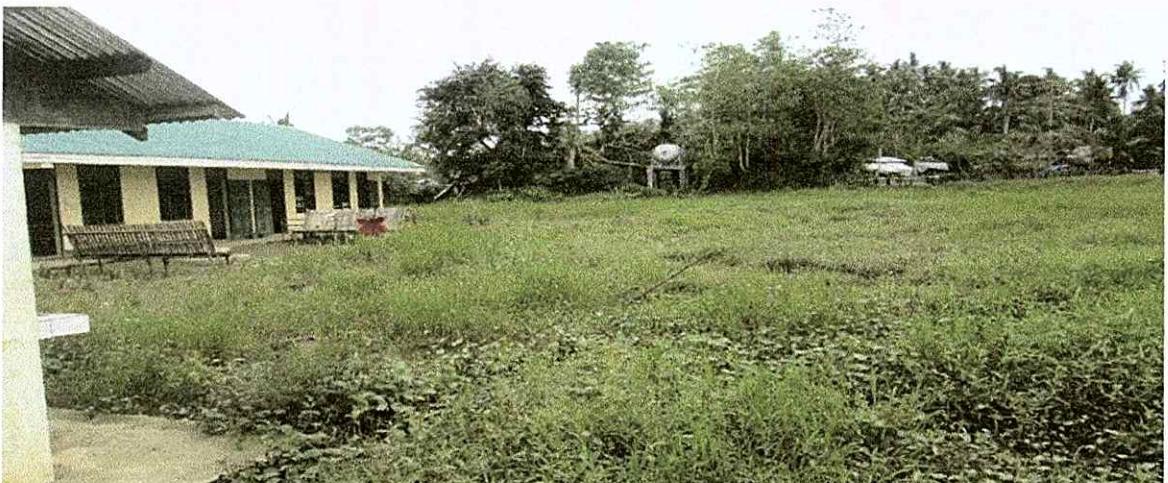
AIS campus is prone to flood

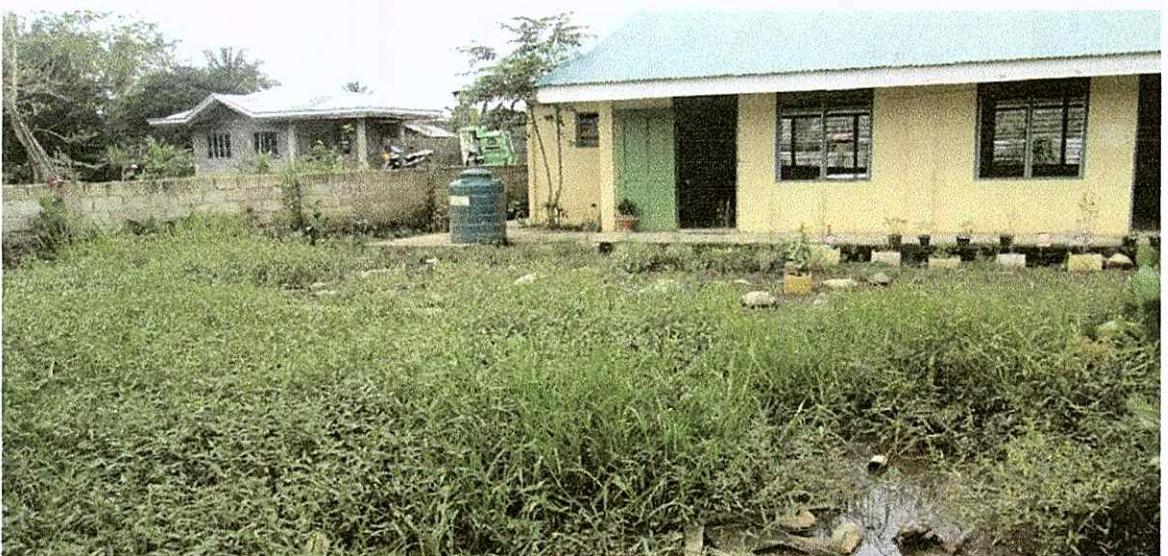
AIS campus is prone to flood.

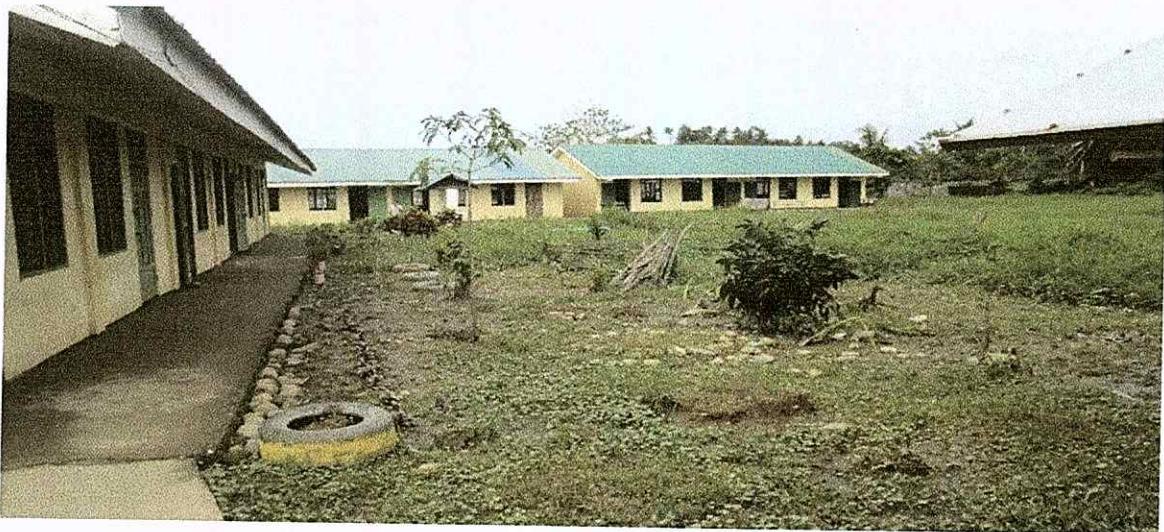
AIS campus is flood prone

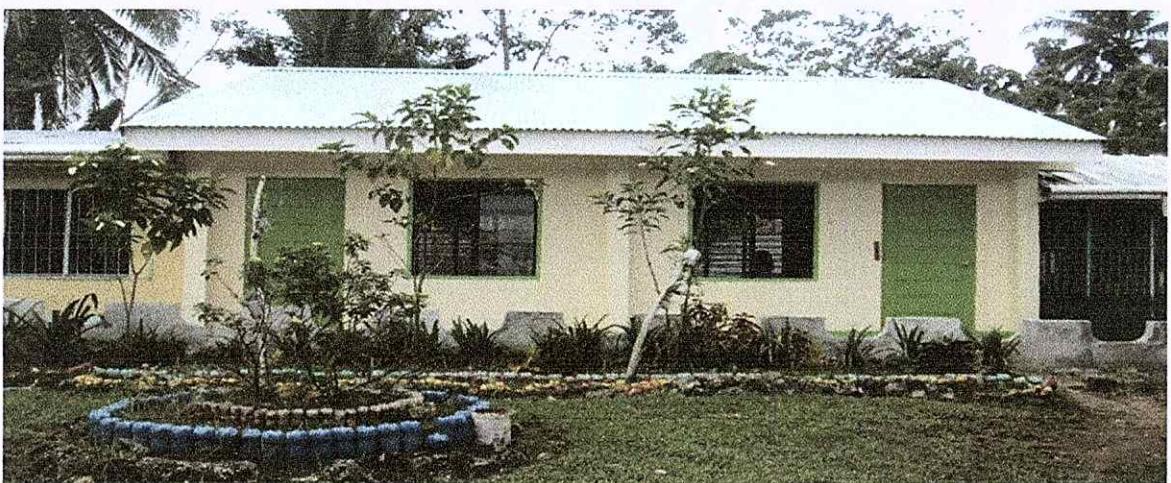
Building 7. Makeshift No. 1

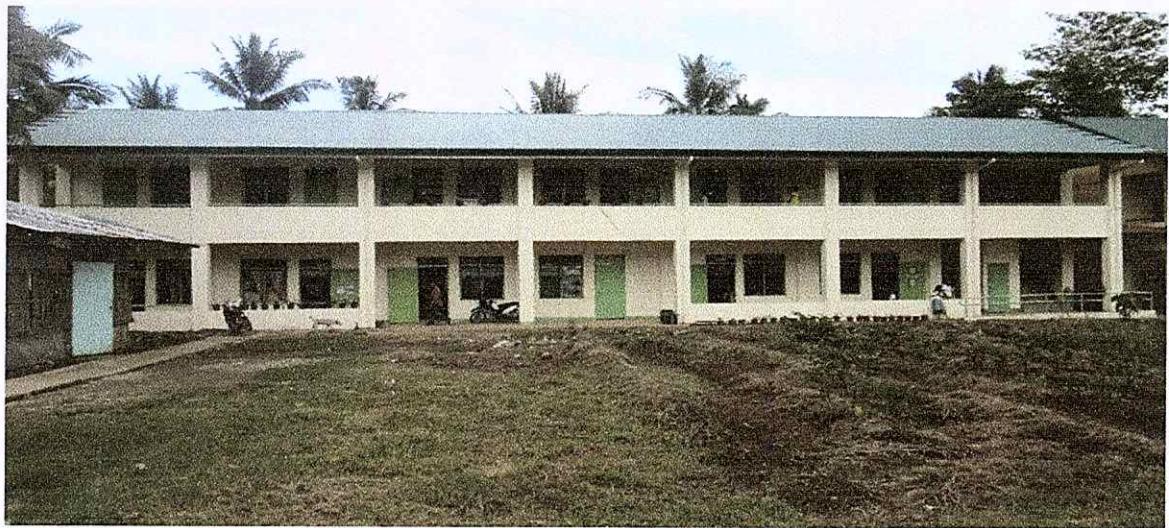
Building 12. Makeshift

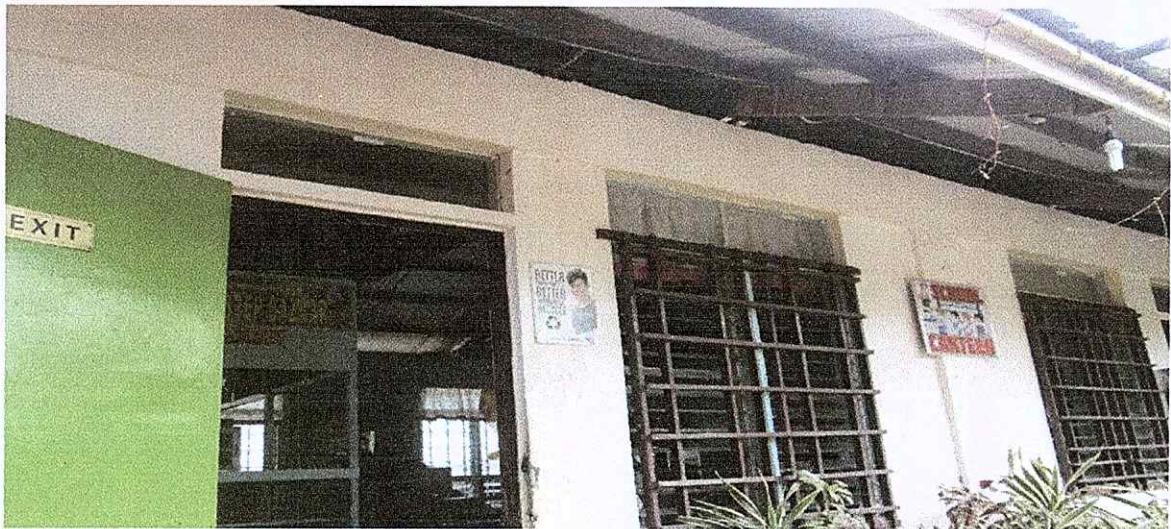
Shown in the picture is the wooden truss and wooden purlins as well as the ceiling of Building 5.

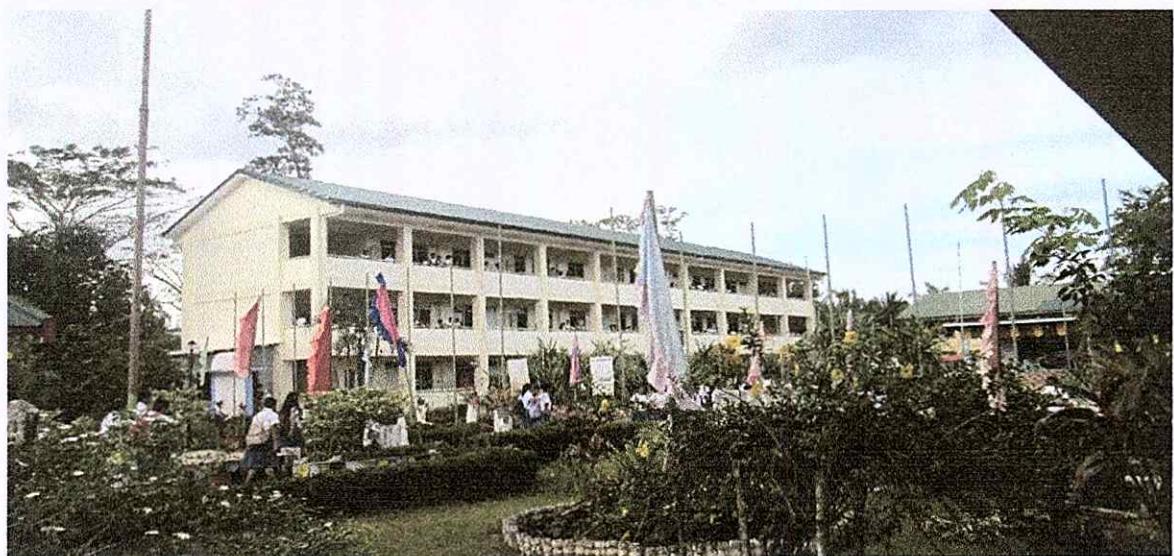
The hallway of Building 16 showing the opening at the front of the building.

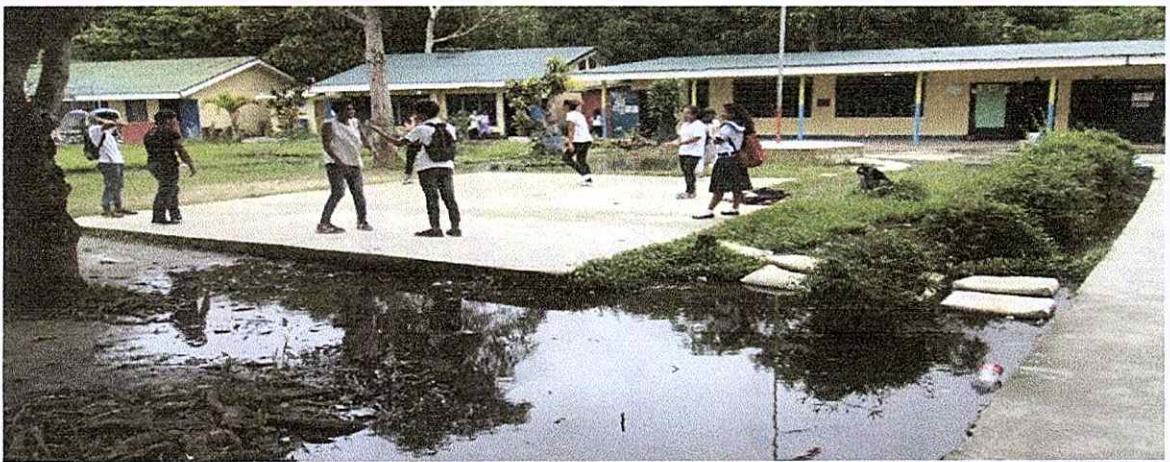
GNHS is prone to flood due to none existence of drainage.

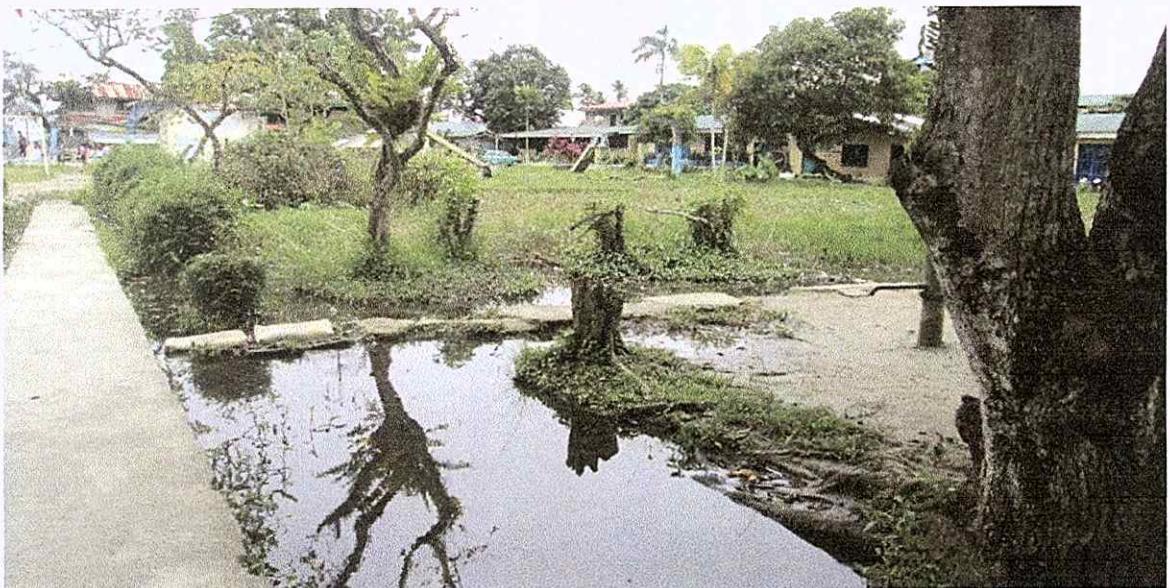
The plaza at GNHS is flooded.

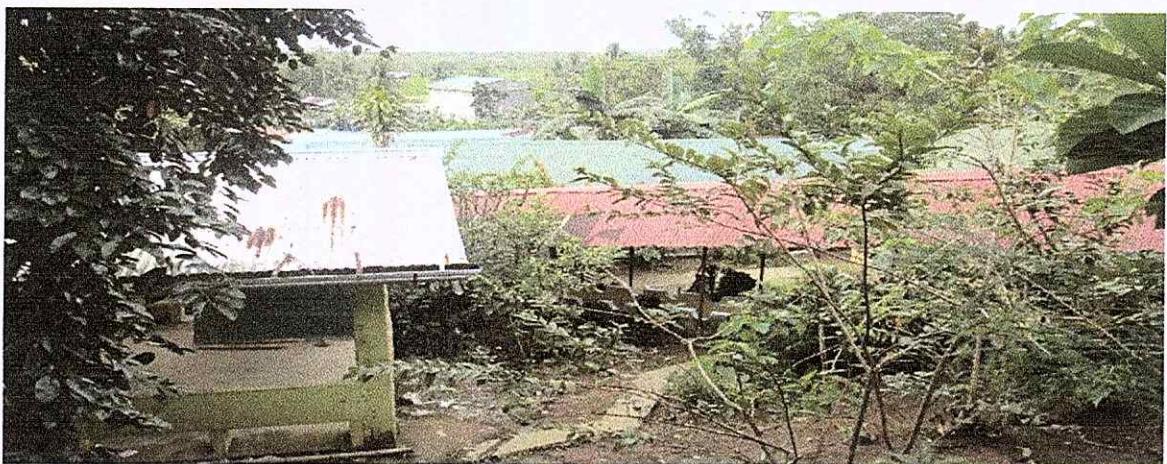
The hill where INHS is situated.

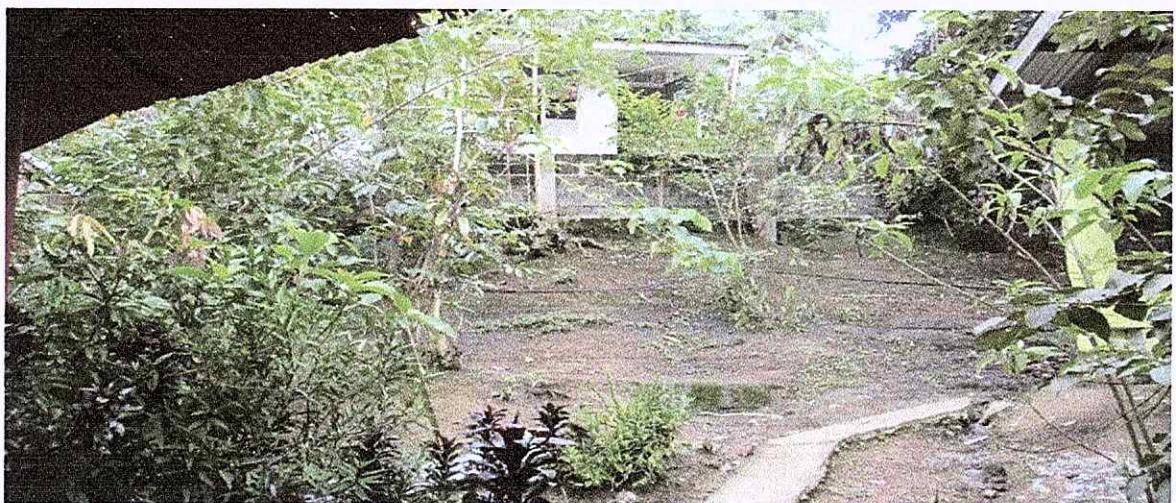
The terrain of INHS campus.

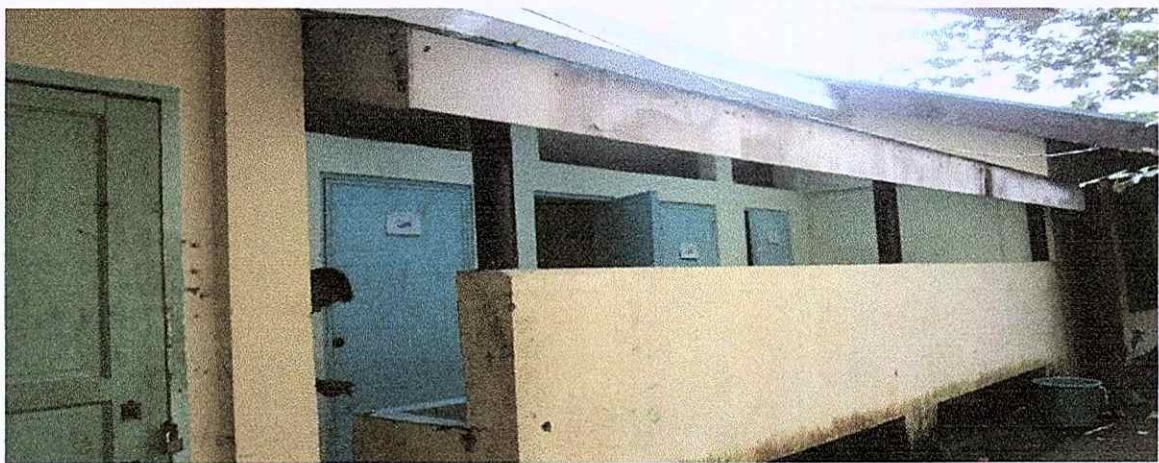
A clear view of the damage portion of Building No. 8

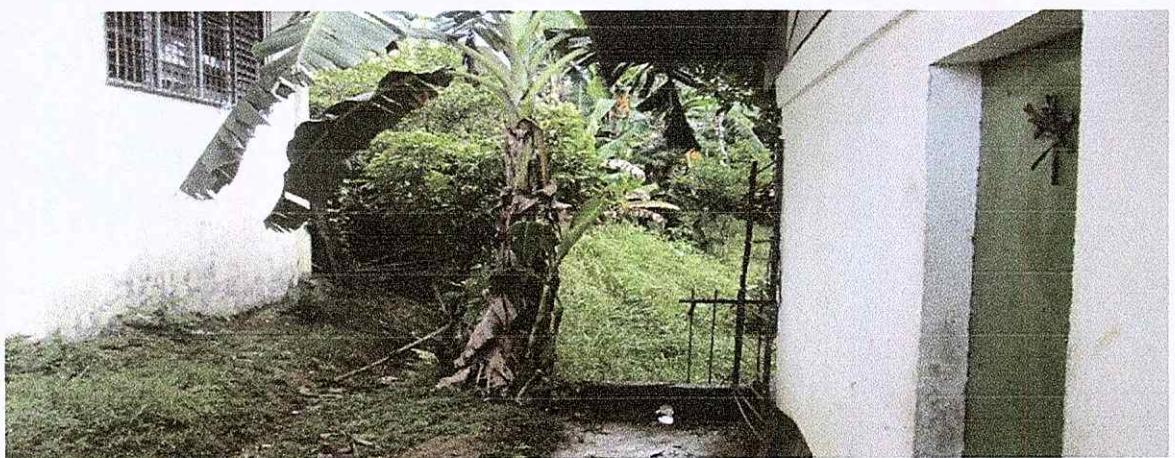
The terrain behind Building 6

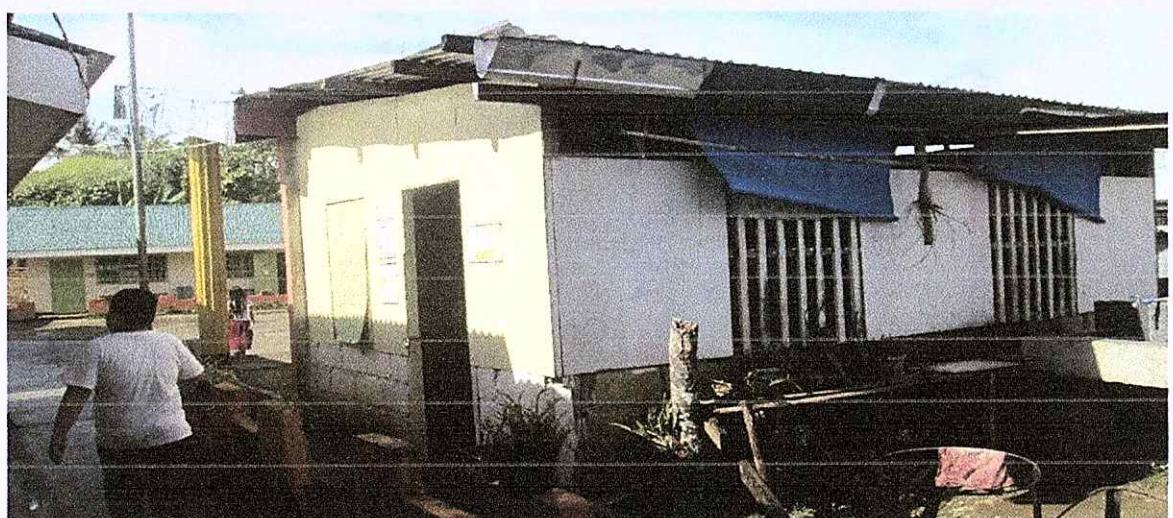
Building 2. A makeshift Reading Center.

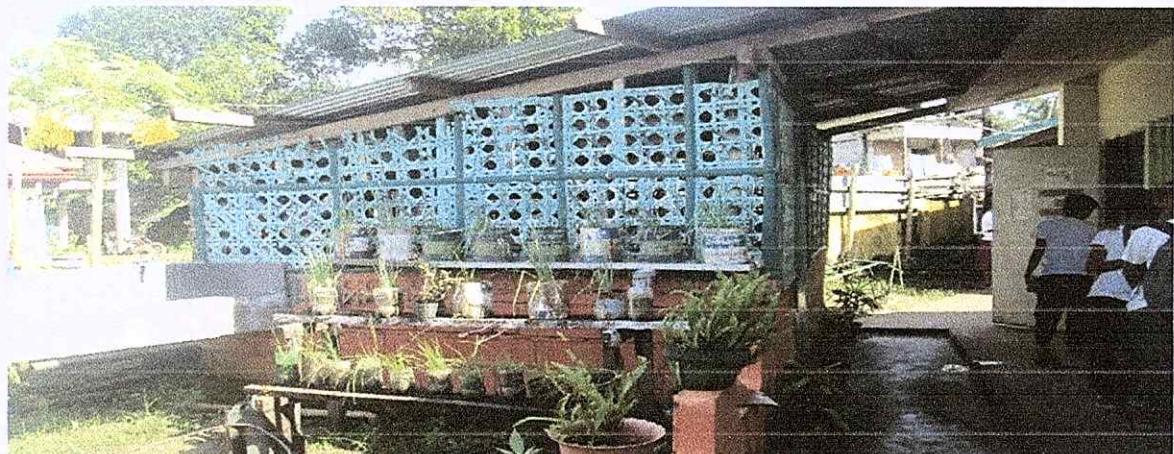
Building 3. A makeshift for washing facility.

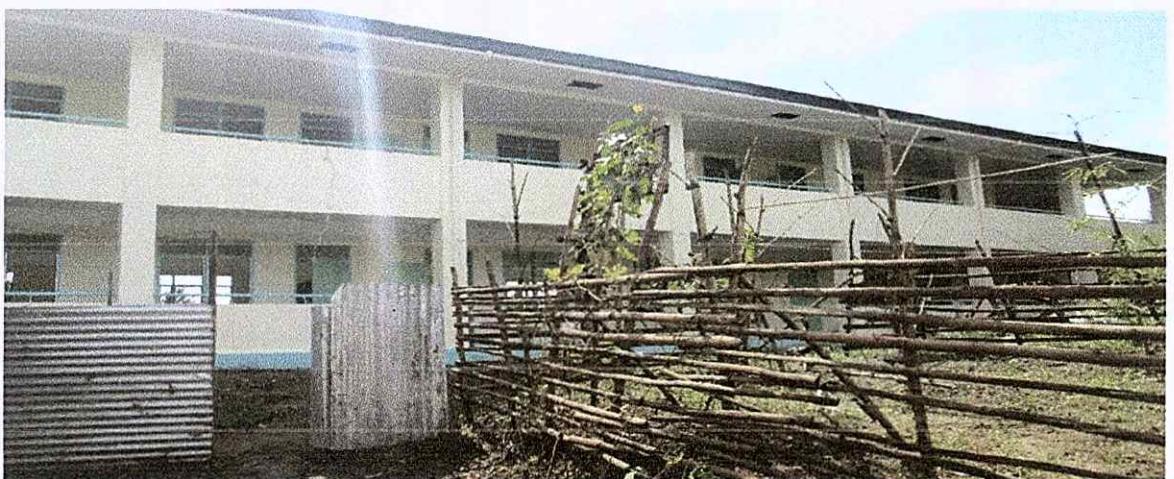
Building 12. A makeshift classroom

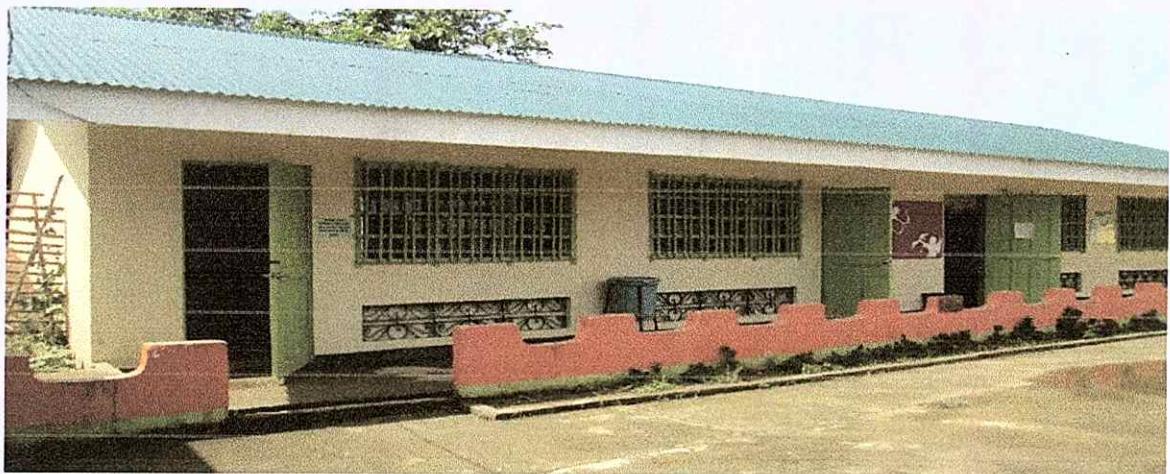
Building 13. On going construction of the building.

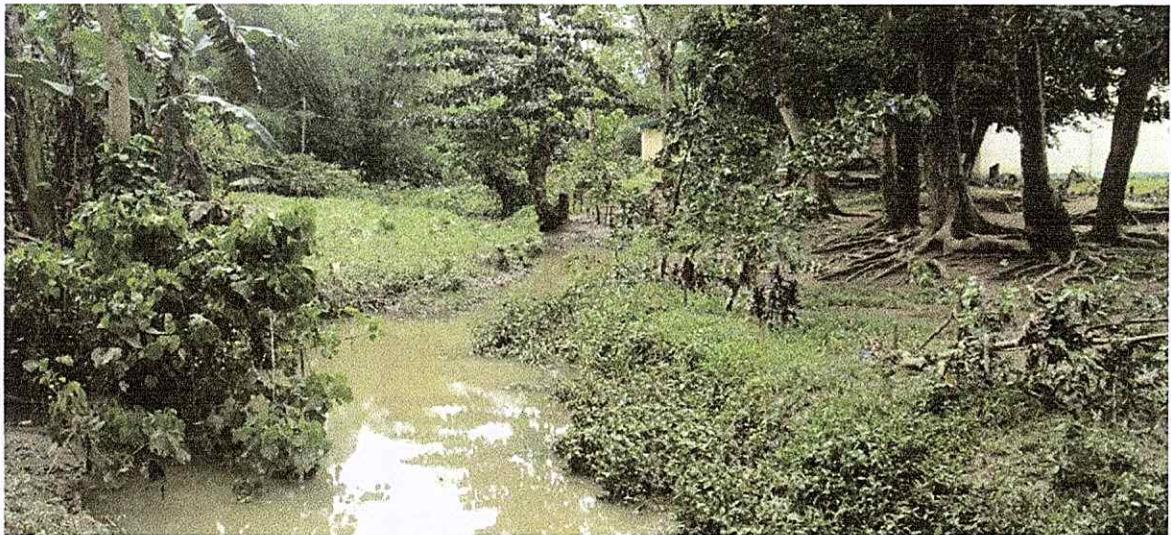
The adjacent river behind Building 1

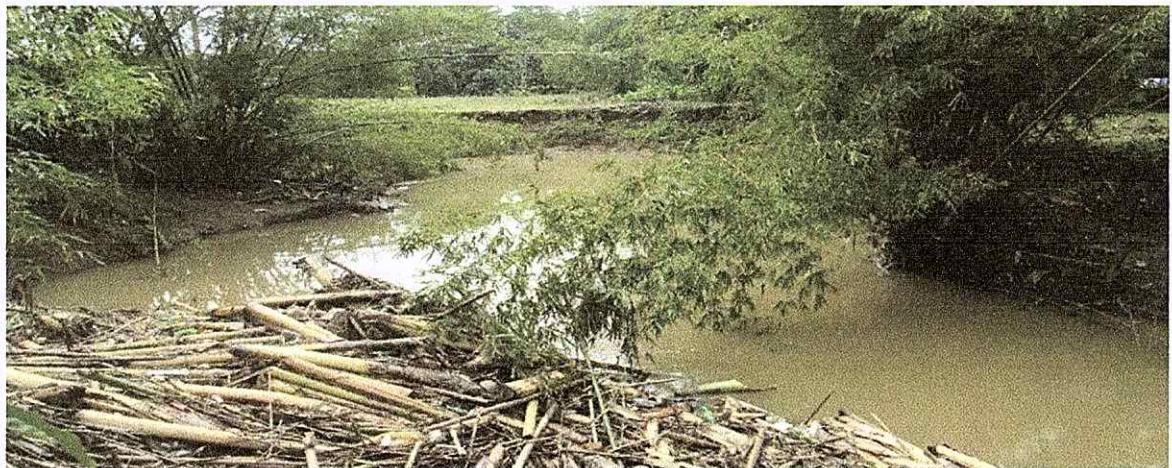
QQSAS is prone to flooding because of the adjacent river.

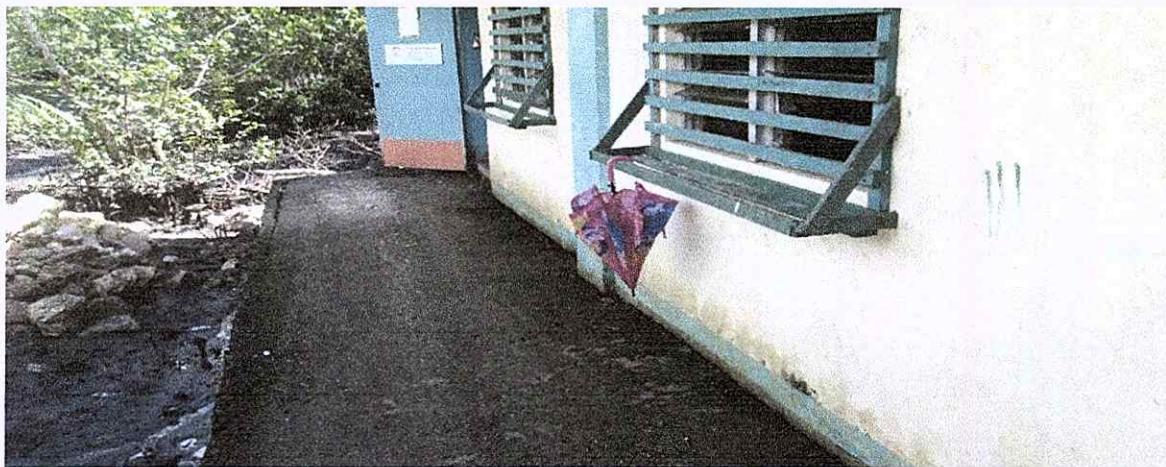
Beside Building 7 are mangrove plantation. It shows that SSNHS is prone to flooding

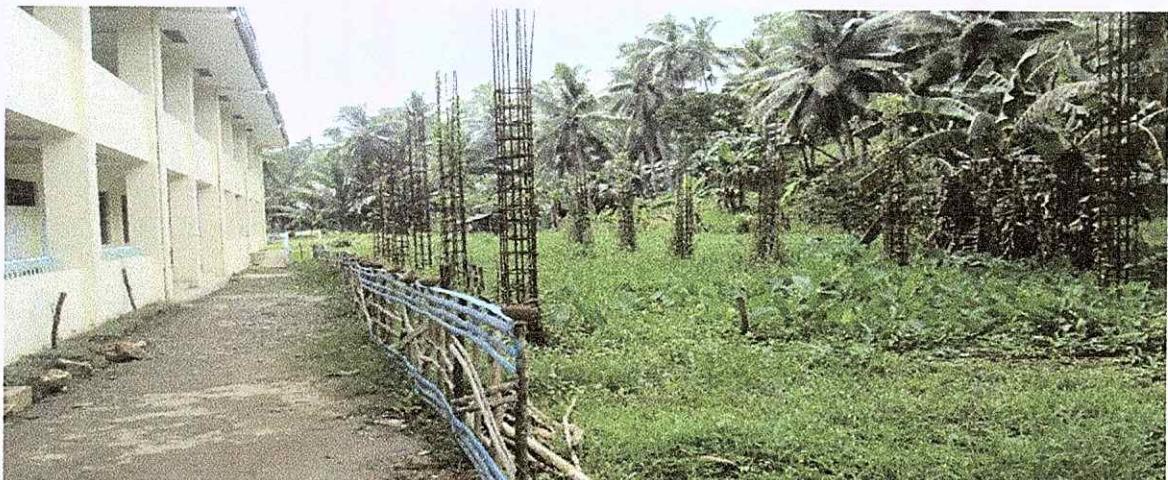
Adjacent Building 13 is a hill to right of it.

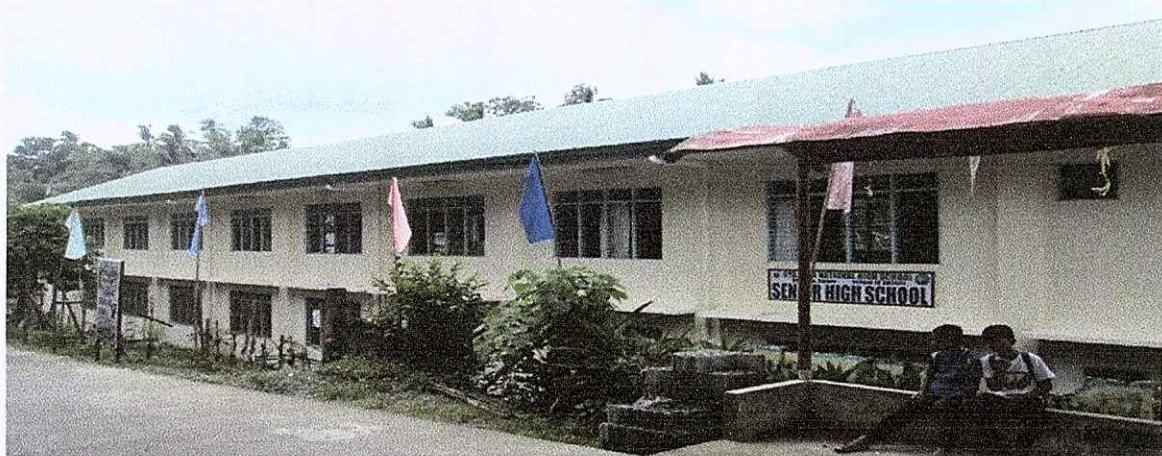
SRNHS is below the highway. Photo taken at the highway.

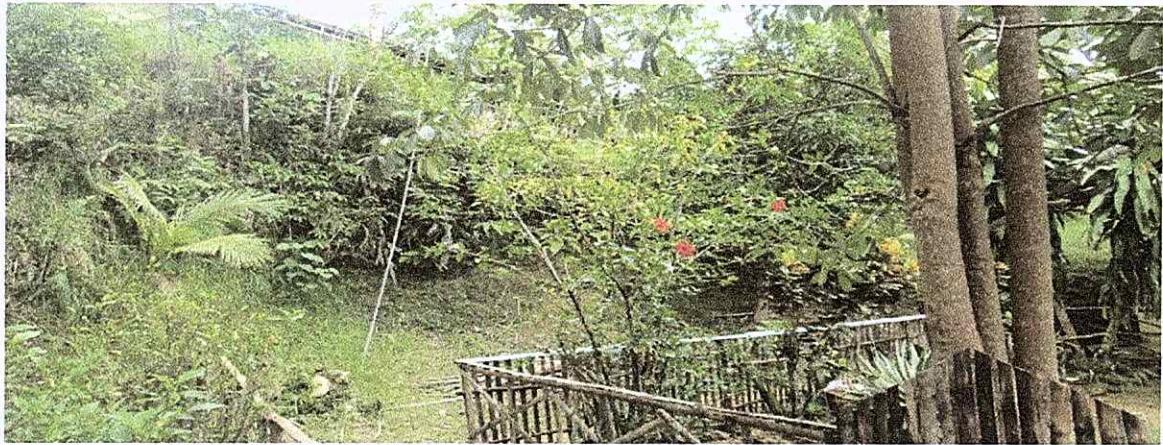
Building 2 is located up the hill. Shown in the photo is the hill where Building 2 is located.

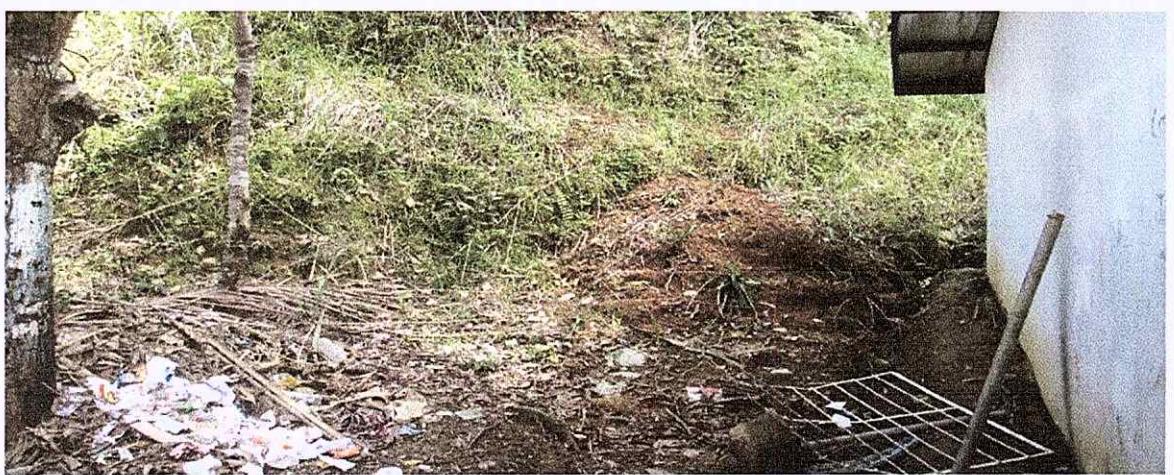
The hill behind Building 3 and Building 4.

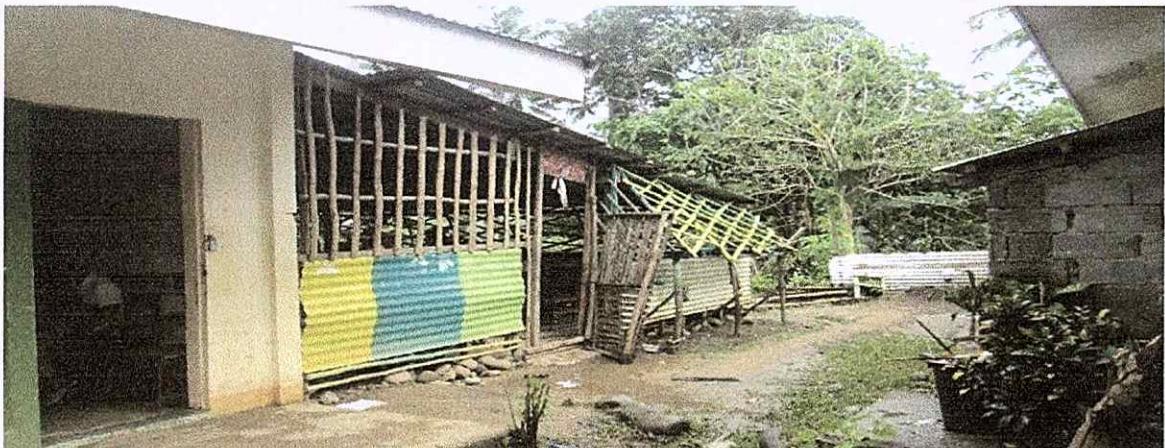
Building 2. A makeshift classroom.

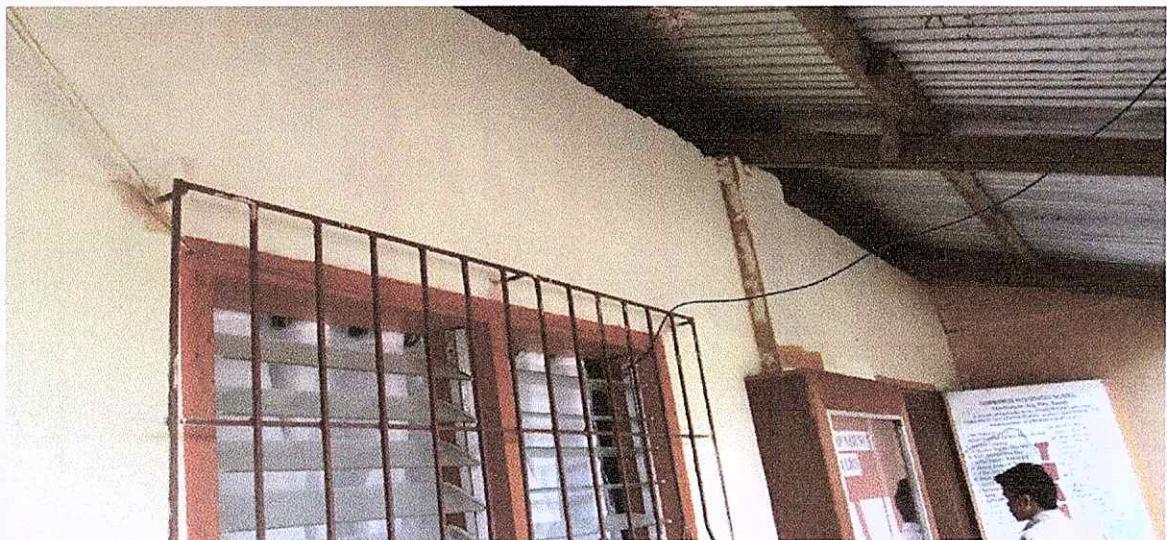
The ceiling of Building 6.

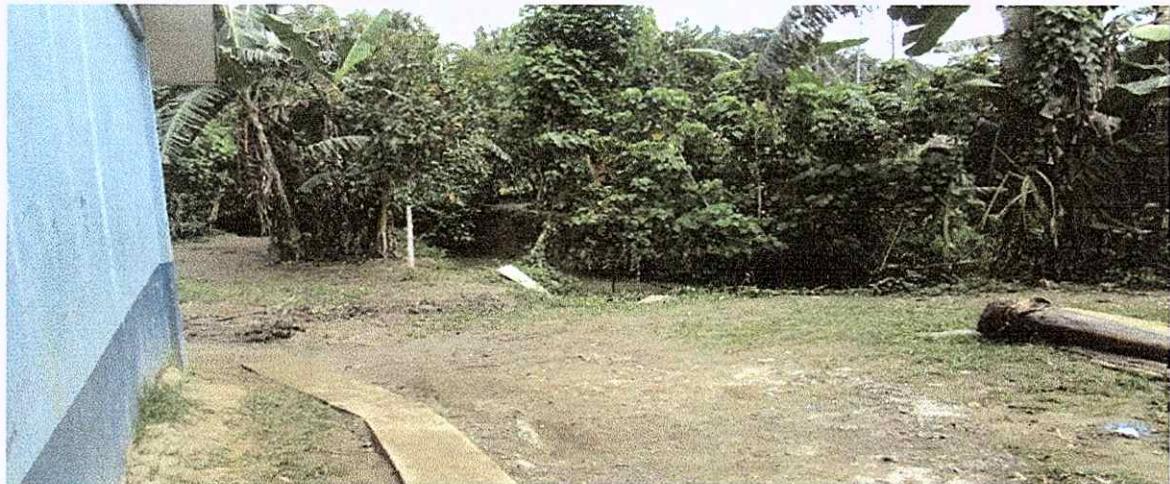
The river behind Building 8. Tominamos Integrated School is prone to flood.

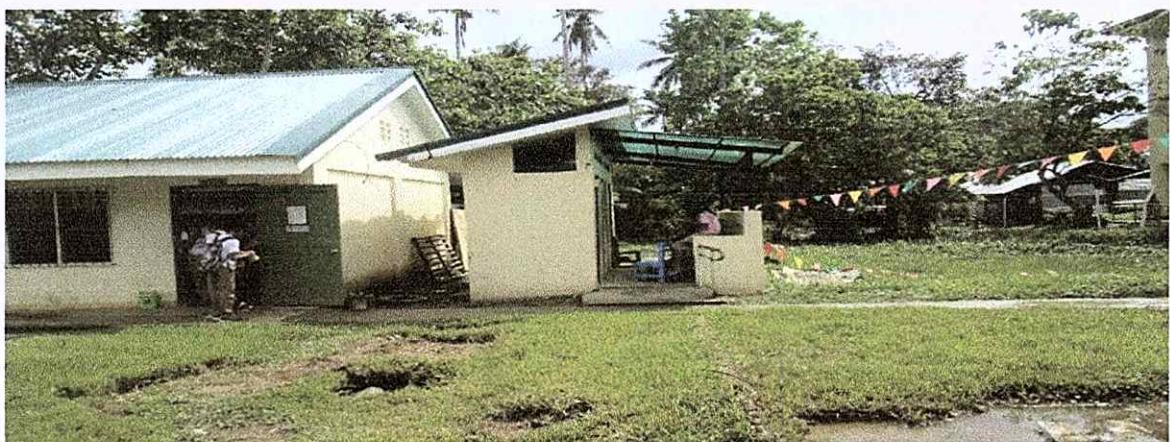
The TIS campus is prone to flood.

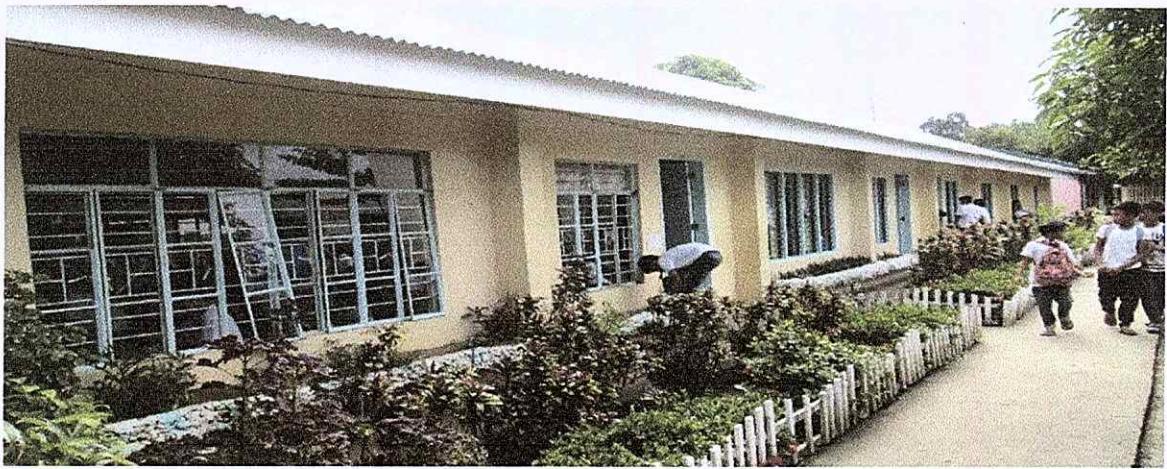
Building 2 showing the casement type window at the left end of the building

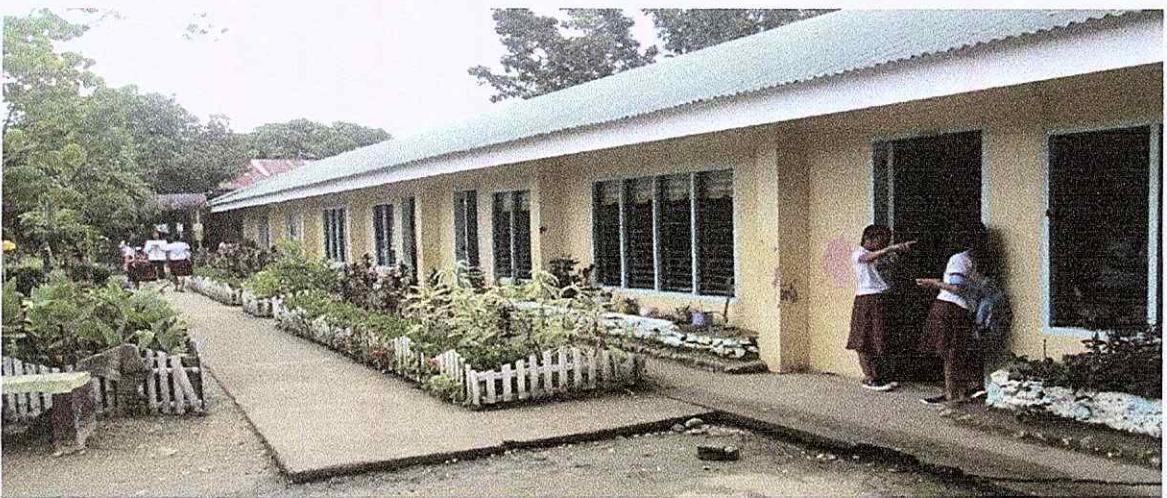
Building 2 showing the glass jalouses at the right end of the building.

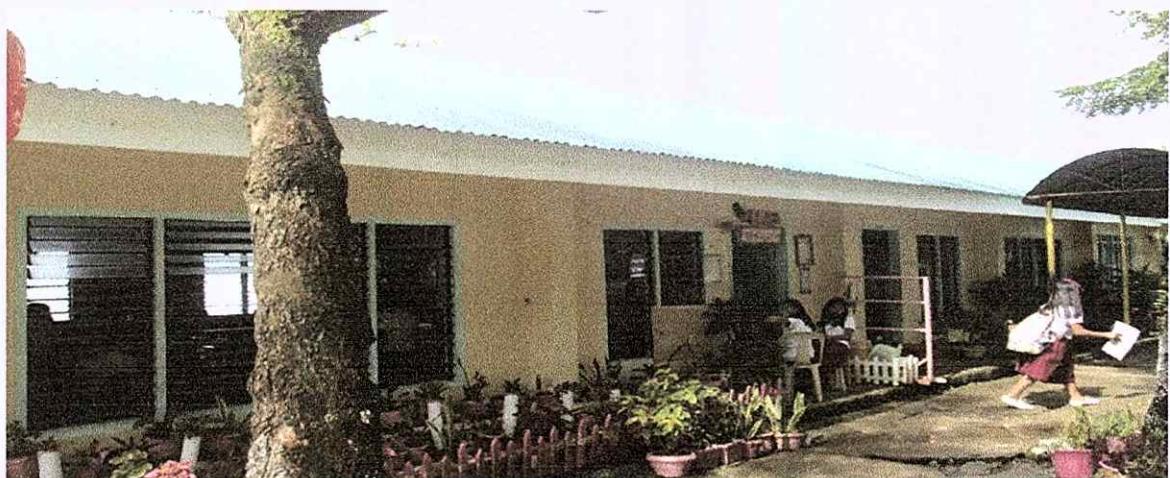
Building 10 showing the casement type window at the left end of the building.
